April 13th, 2018

CRITICAL INFRASTRUCTURE IN BENGAWAN SOLO RIVER

RIA ASIH ARYANI SOEMITRO

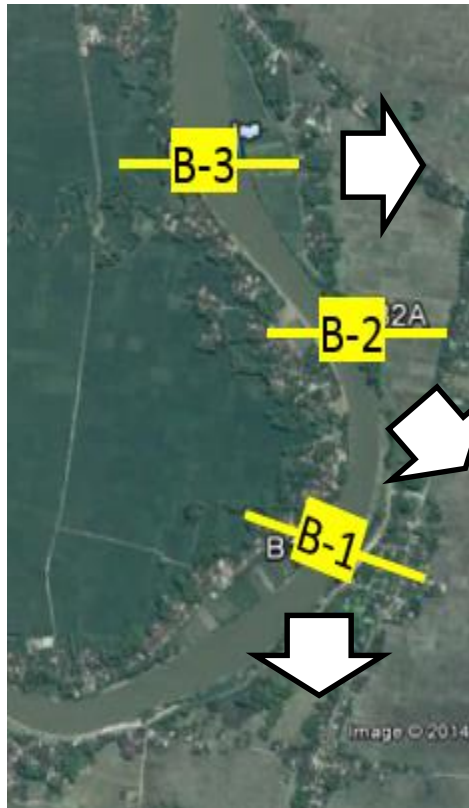
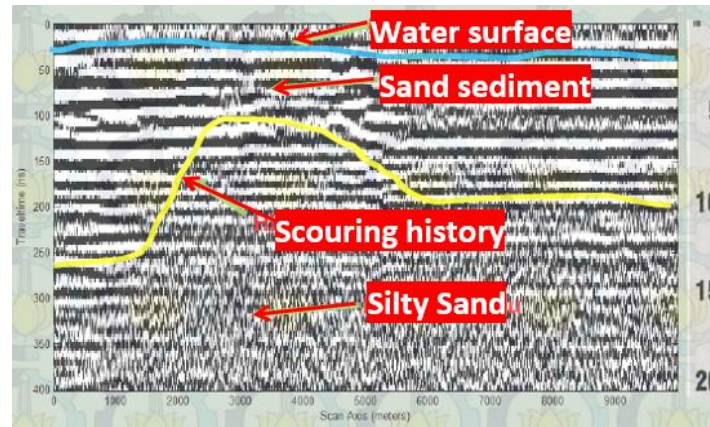
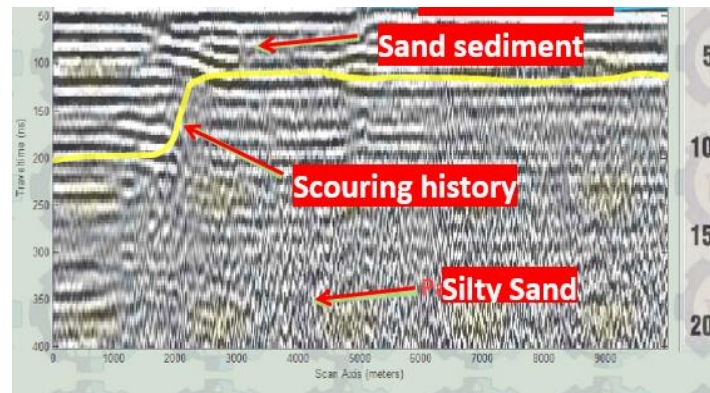
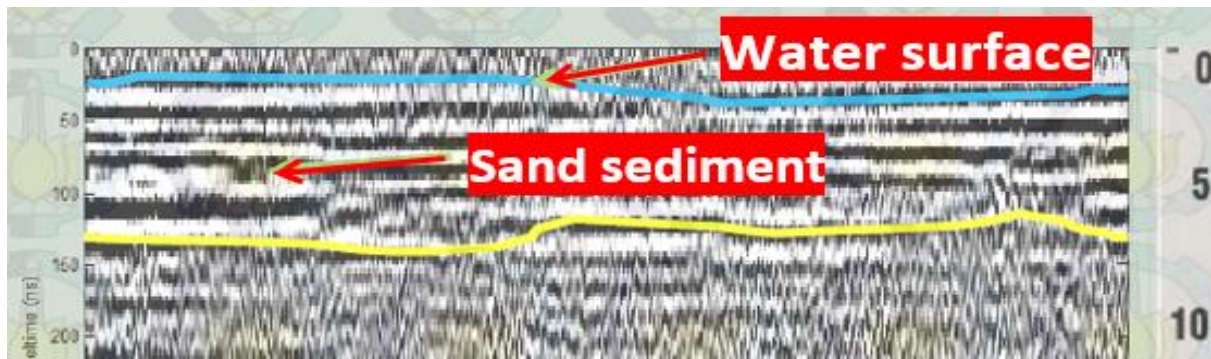
- River bed profile soil condition (from Georadar test)
- B-2 and B-3 has high impact scouring river profile than B-1
- Meandering area reduced river current, but high pressure of sedimented water led river profile scouring

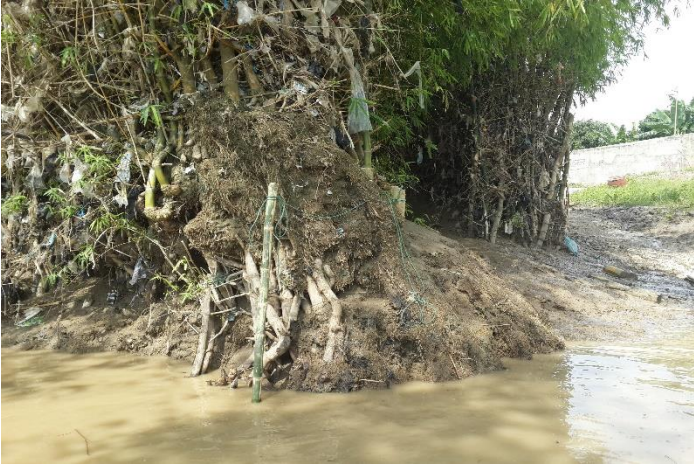
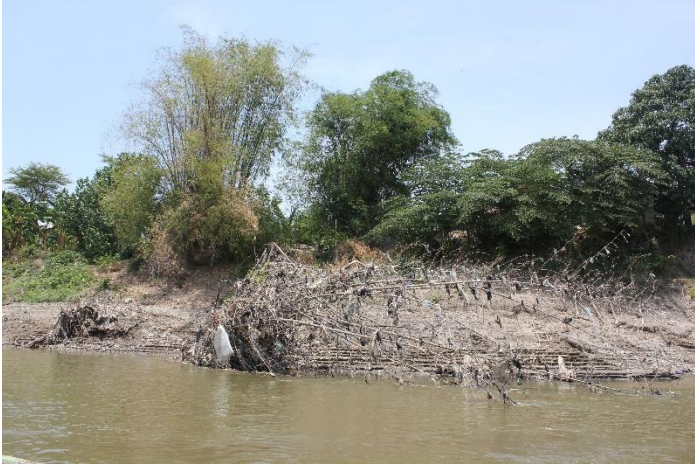
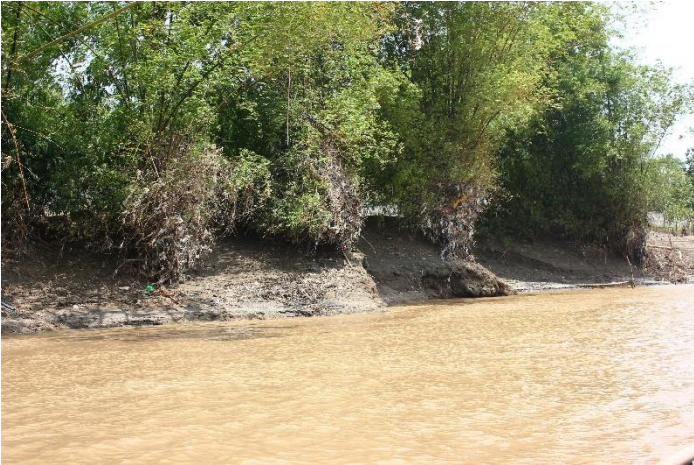
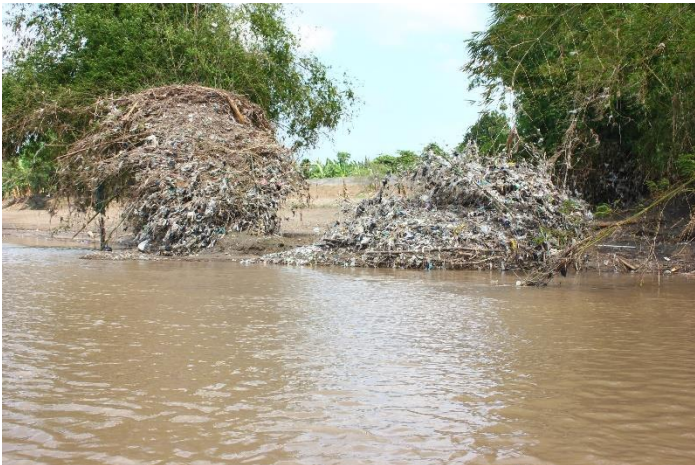
Embankment failure at Bamboo Vegetation Area

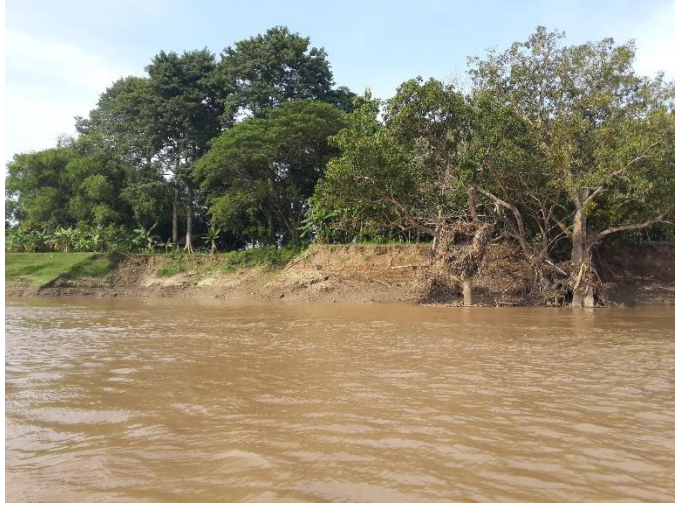
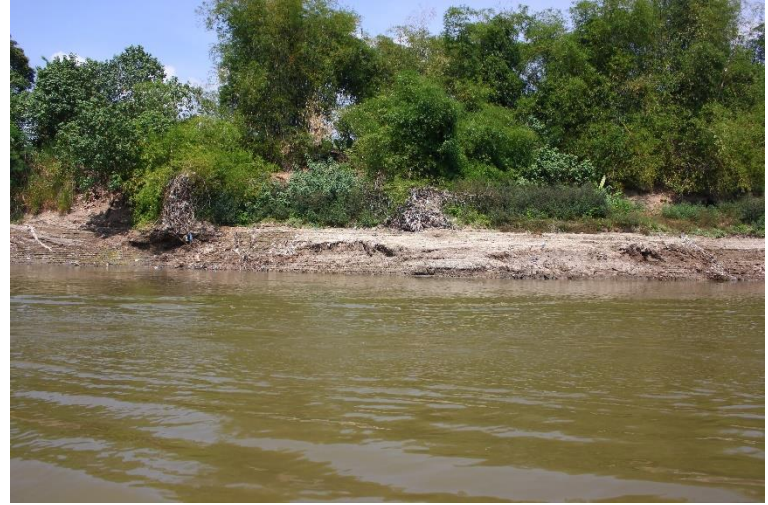
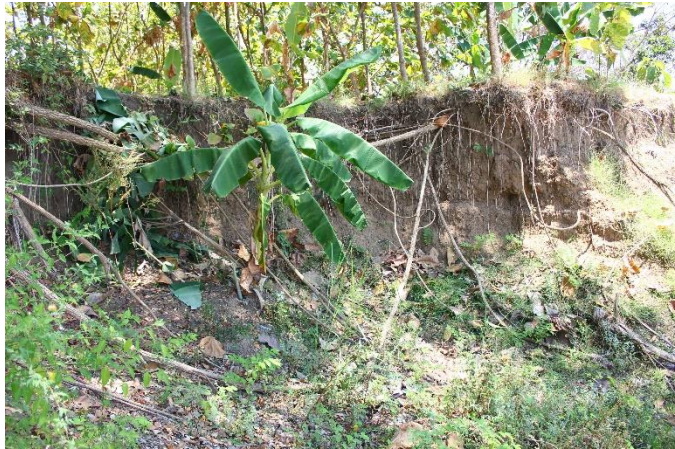
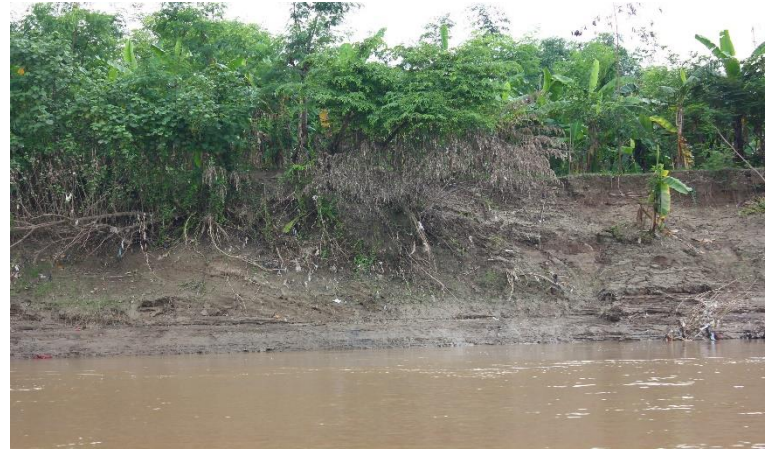
Embankment failure at Acacia Vegetation Area

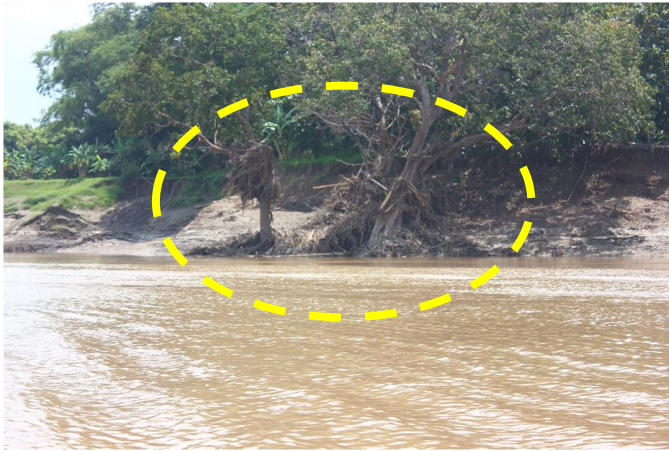
- Uprooted Bamboo and other vegetation were stacked on the tree as flood outcomes in Bengawan Solo River, 2014

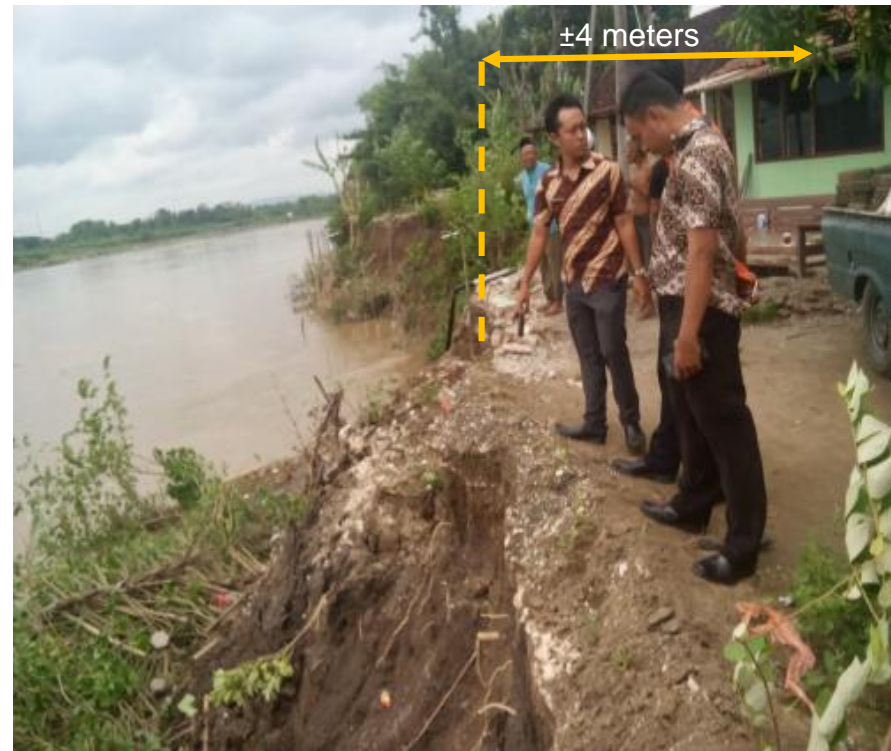
- Failure embankment which located in flood plain Bengawan Solo River was occurred in Banjarejo Village, Bojonegoro remaining 4 m space between river and residence house.
- According to the Minister of Public Work and Public Housing Code No. 28/PRT/M/2015 Chapter 6(2) as concerns river and reservoir flood plain border, it is stated for primary river should be 100 meters of right and left sides of river in minimum.

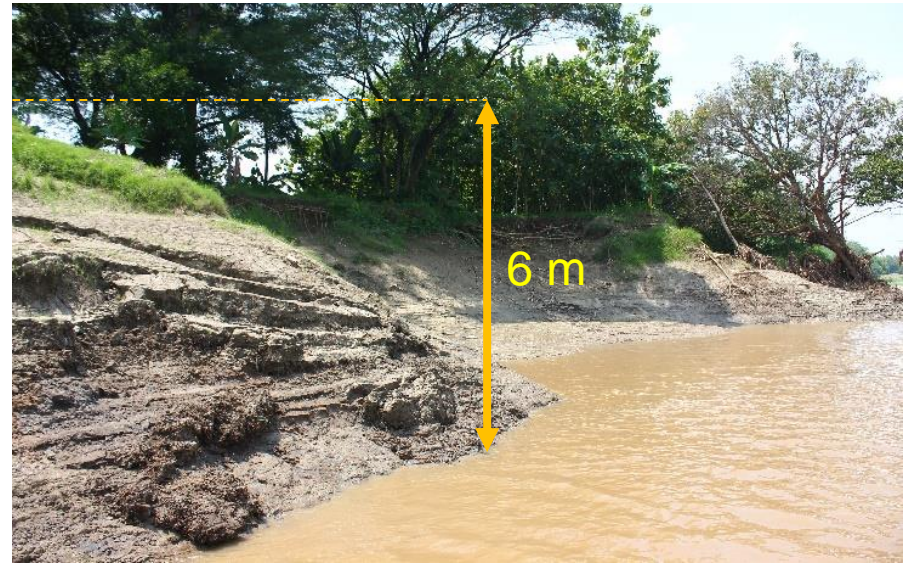
Embankment toe failure after flood in Bengawan Solo River, 2014

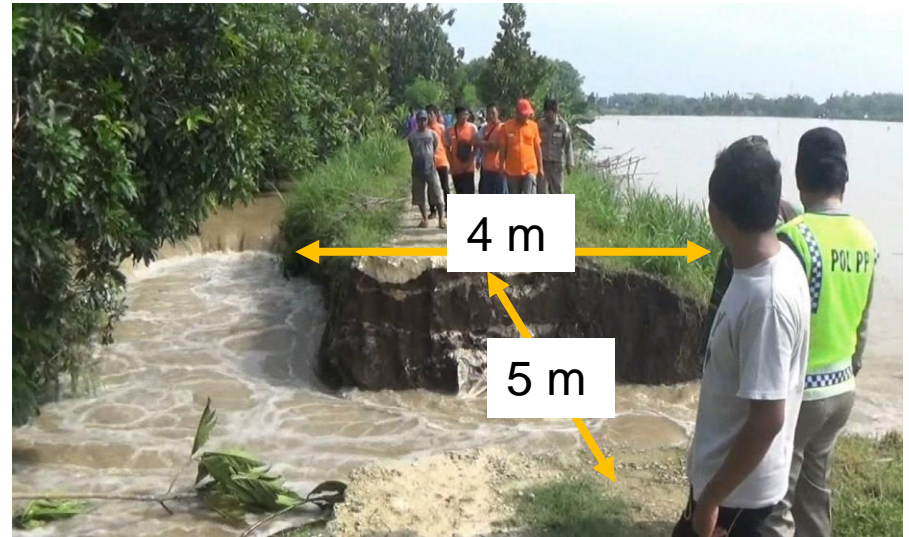
Manmade embankment failure of Bengawan Solo River in Lamongan District, 2017
(Source: citratv.co.id)

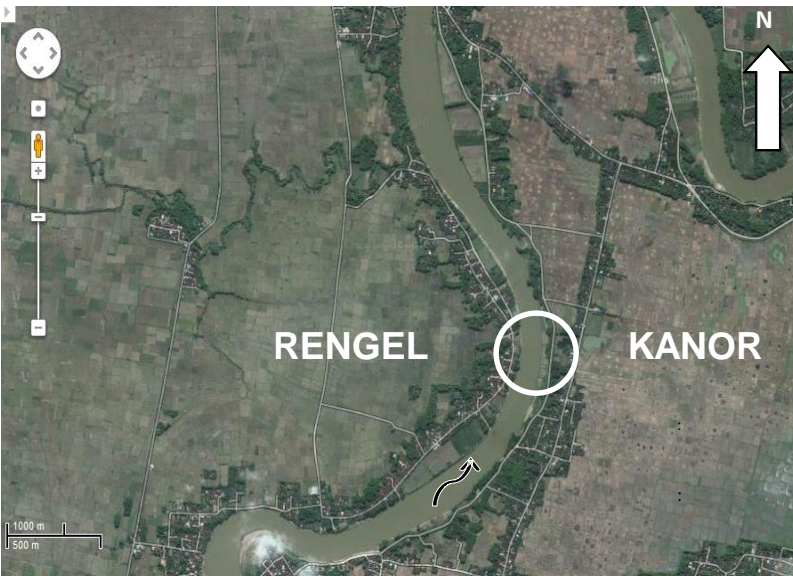
- River bed erosion occurred at Kanor side due to high flow velocity.
- Sediment deposition exist around inner bend at Rengel side developed by low flow velocity.
- Excessive flood is frequently happened in this section.

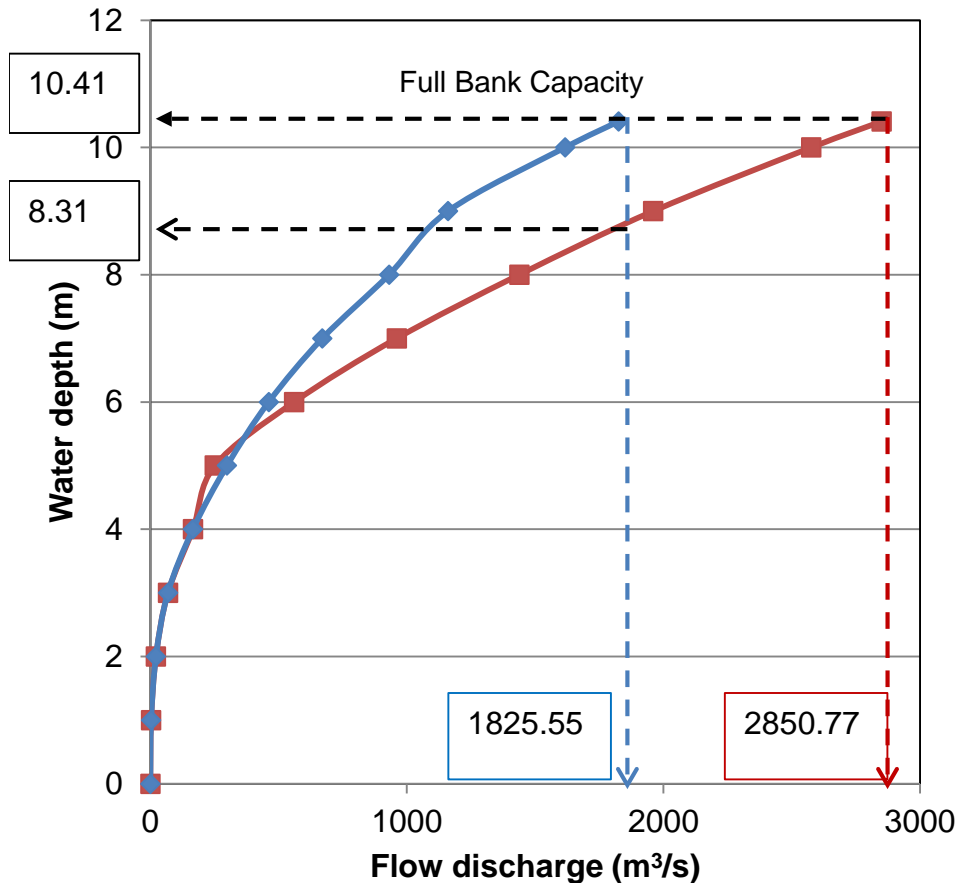
Rating curve of Bengawan Solo River,
Kanor section

- In existing condition, the over topping flow occurred when the flow discharge reach 1825.55 m³/s.
- By excavating 2- 3 m of sediment material will increase channel capacity up to 2850.77 m³/s or 56% bigger than existing condition.

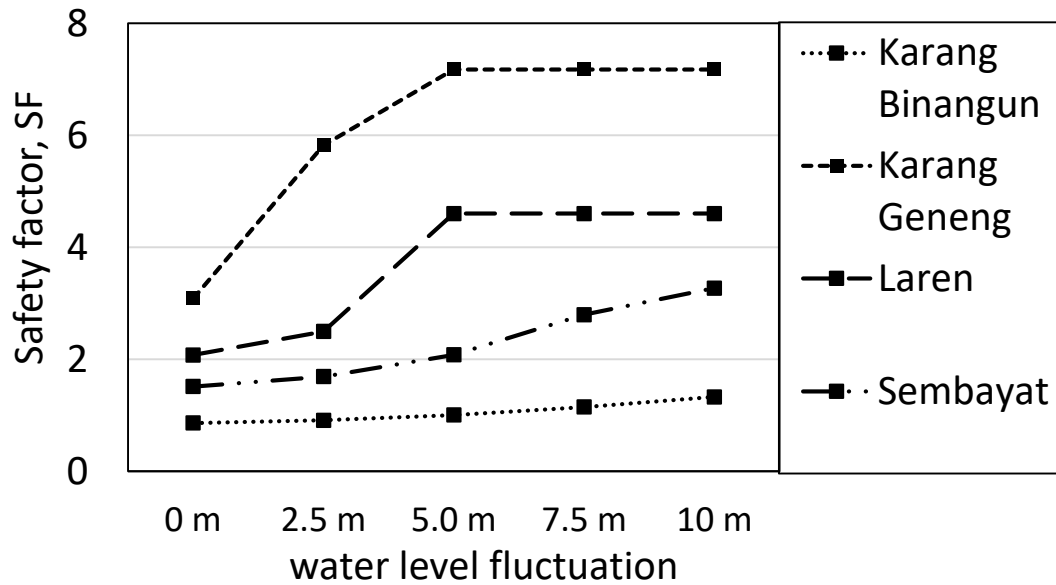
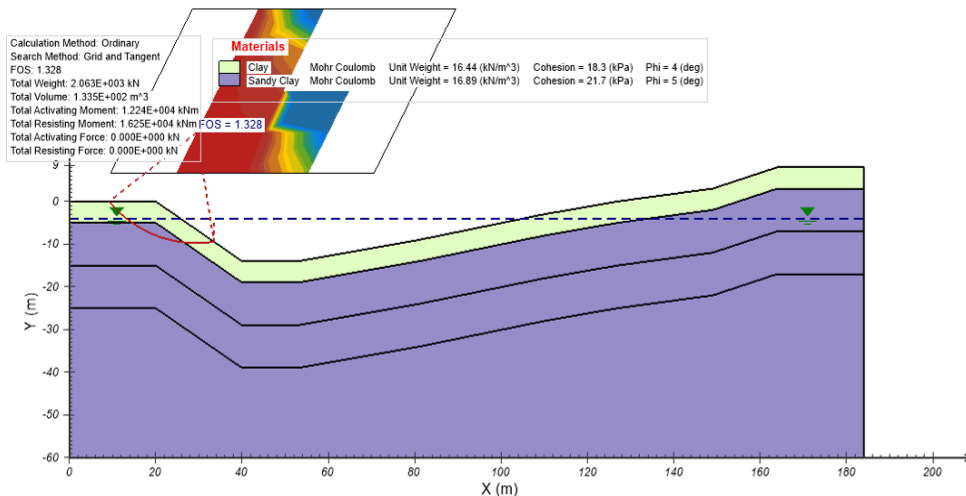
- Karang Binangun was the most critical condition ($SF < 1.5$) due to water level change
- Karang Geneng was the stable structure ($SF > 1.5$) since possessing flatter slope
- Considering the unsaturated condition beyond water level, the embankment stability should be re-analyzed.

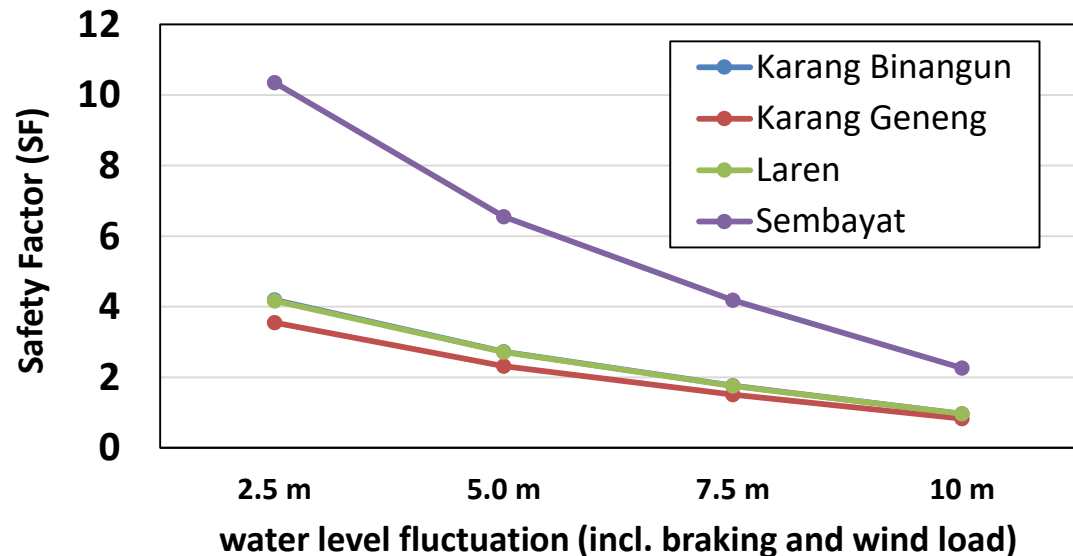
- Load of sediment and water flow increases due to water level
- Foundation stability was influenced by additional load from sediment and water
- Karang Binangun, Karang Geneng and Laren bridges are vulnerable to water level fluctuation below 5 m
- Sembayat was the most stable structure since no impact area existed on the foundation

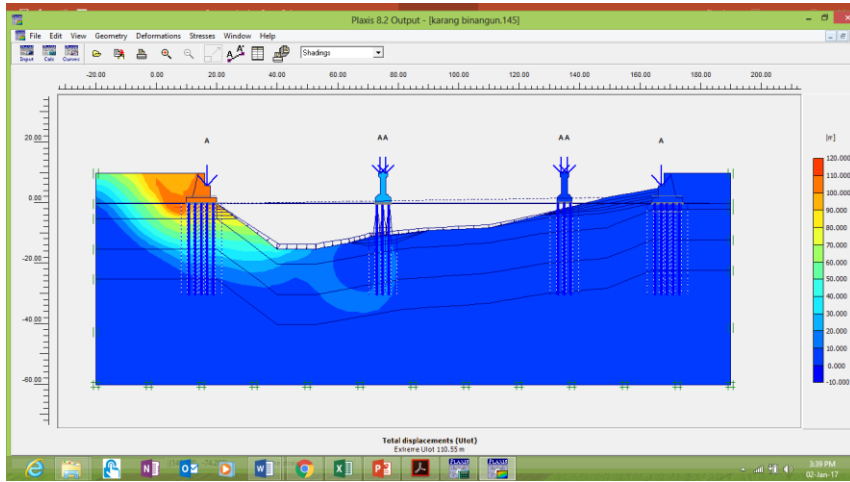
- Karang Binangun was the most critical condition due to water level change
- The slope is tend to be collapsed due to water level change

Location	Initial	Remark	Scoured 1 m	Remark	Scoured 2 m	Remark	Scoured 3 m	Remark
Karang Binangun	1.119	< 1.5	1.118	< 1.5	1.115	< 1.5	1.111	< 1.5
Karang Geneng	1.808	> 1.5	1.791	> 1.5	1.741	> 1.5	1.730	> 1.5
Laren	1.781	> 1.5	1.783	> 1.5	1.779	> 1.5	1.779	> 1.5
Sembayat	1.644	> 1.5	1.618	> 1.5	1.615	> 1.5	1.611	> 1.5

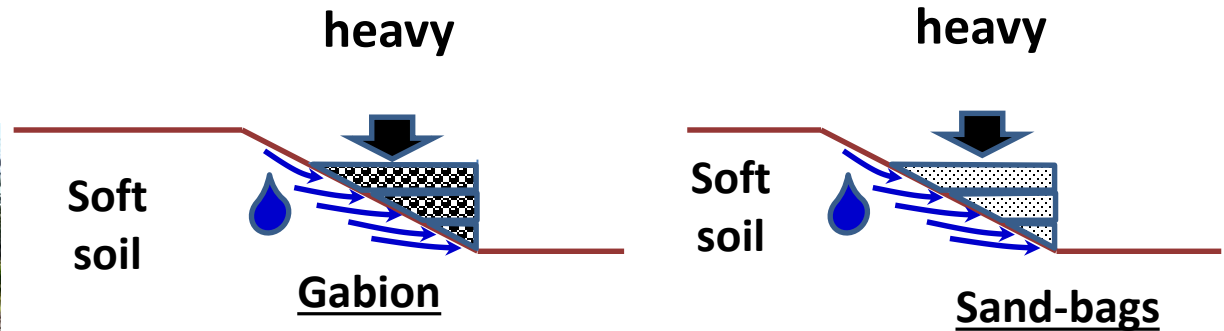
Gabion and sand-bags for slope protection

- Water is flowing into the protection **without** barriers
- Protections are laid on the soft soil which has low strength and high compressibility
- Heavy structure since constructed by rock and sand materials
- Soft soil settlement is completed in the following **hundred years**

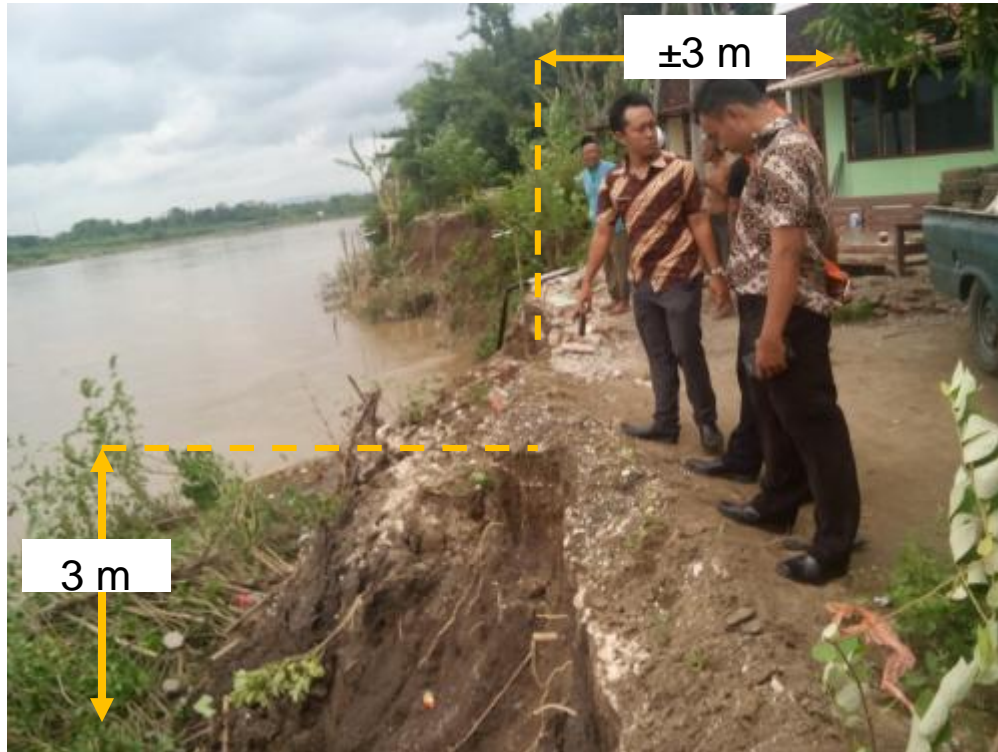
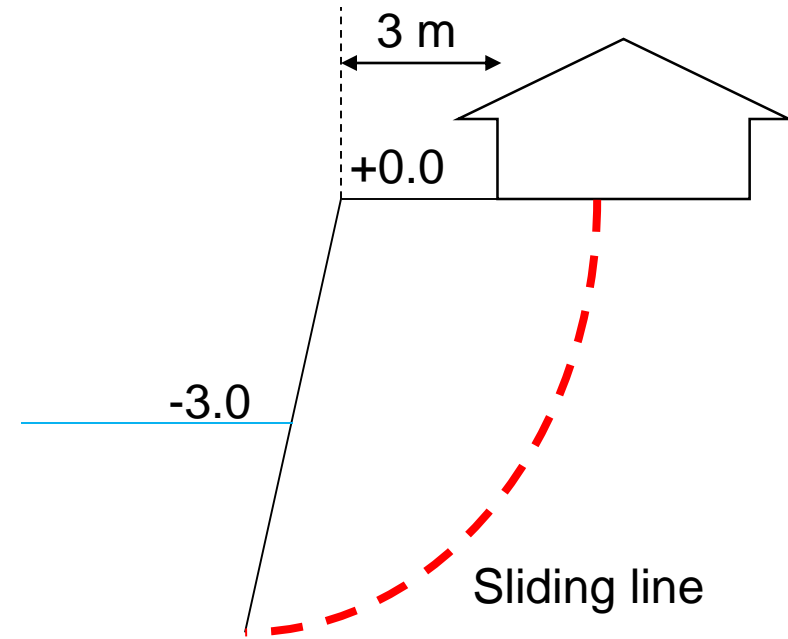
Embankment sliding of Bengawan Solo River next to public housing in Banjarejo Village, Bojonegoro, 2016 (Source: beritajatim.com)

Load distance	Safety factor, SF
3 m	0.96
10 m	1.024
20 m	1.028

Water level	Safety factor, SF
± 0 m	1.028
+ 5 m	1.209
+ 10 m	2.213

Rapid draw down	Safety factor, SF
From +10 m to +5 m	1.190
From +10 m to ± 0 m	1.002

- Conclusion:
 - Regulation of the distance of residential area is required to be applied
 - Slope stability is varied due to water level fluctuation
 - Phenomenon of rapid draw down decreases the river embankment stability
