Damage Extension and Failure Behavior of CFRP Specimens in Open Hole Compression Tests and Analytical Simulation

Tetsuji Kato +, Takashi Ishikawa +, Yasumasa Hamaguchi +, Naoya Shikata ++, and Goichi Ben ++

+ Advanced Composite Evaluation Technology Center, Japan Aerospace Exploration Agency ++ Production Engineering Department, Nihon University

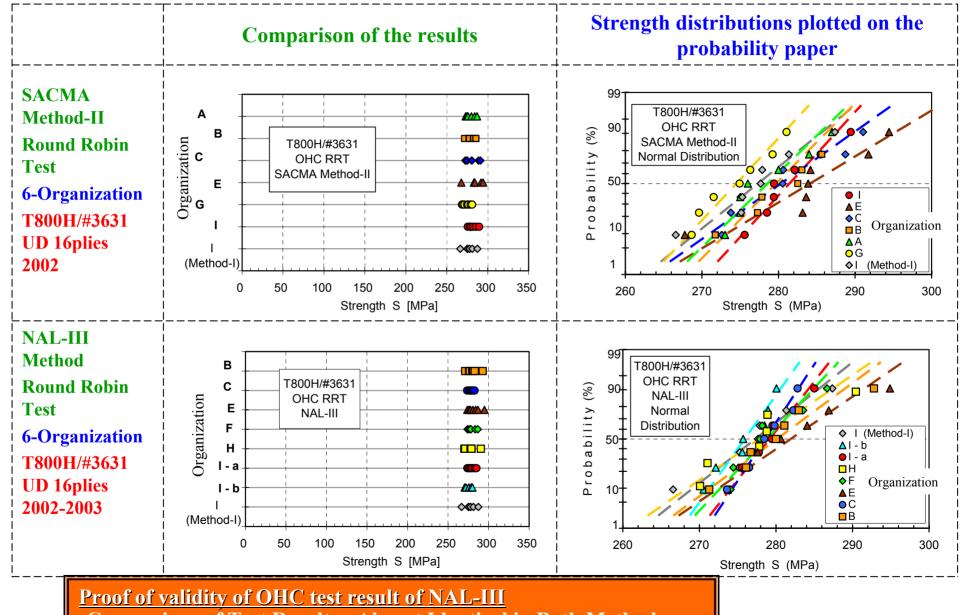
Round Robin Test Results of SACMA and NAL-III OHC Test Method

•Comparison of Test Results : Almost Identical in Both Methods

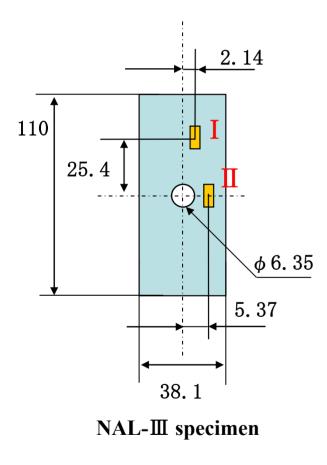
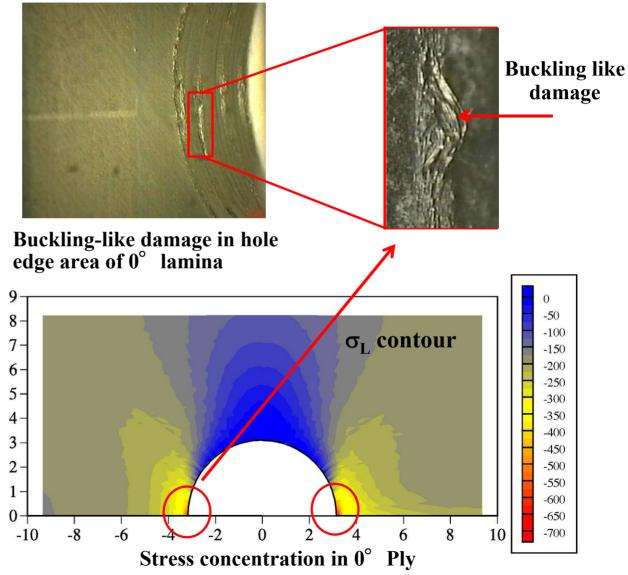
FEM Analysis

Evaluation of Stress Concentration in 0° Ply [(45/0/-45/90)₂]_{sym}- IM600/QC133 OHC Specimen

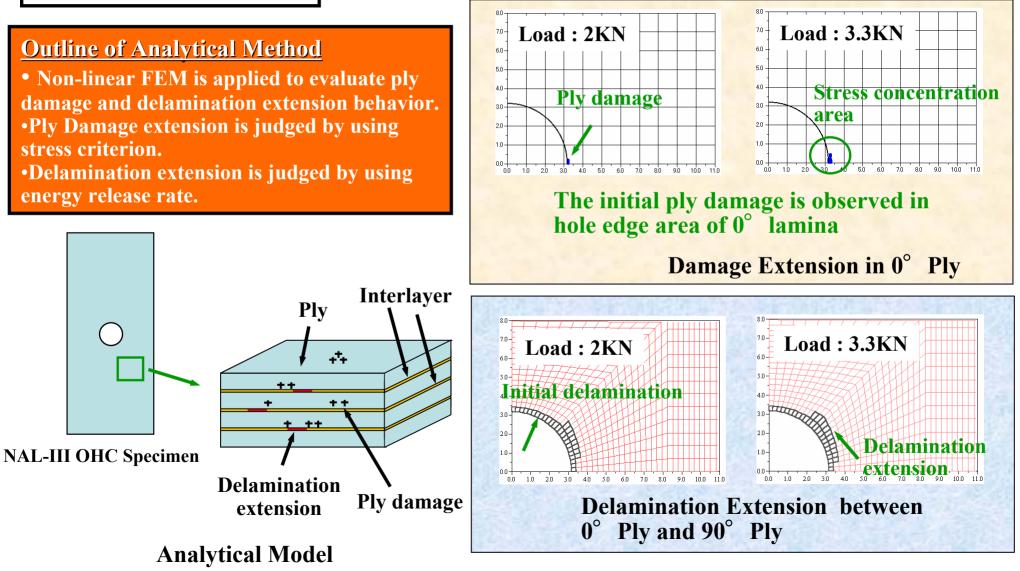
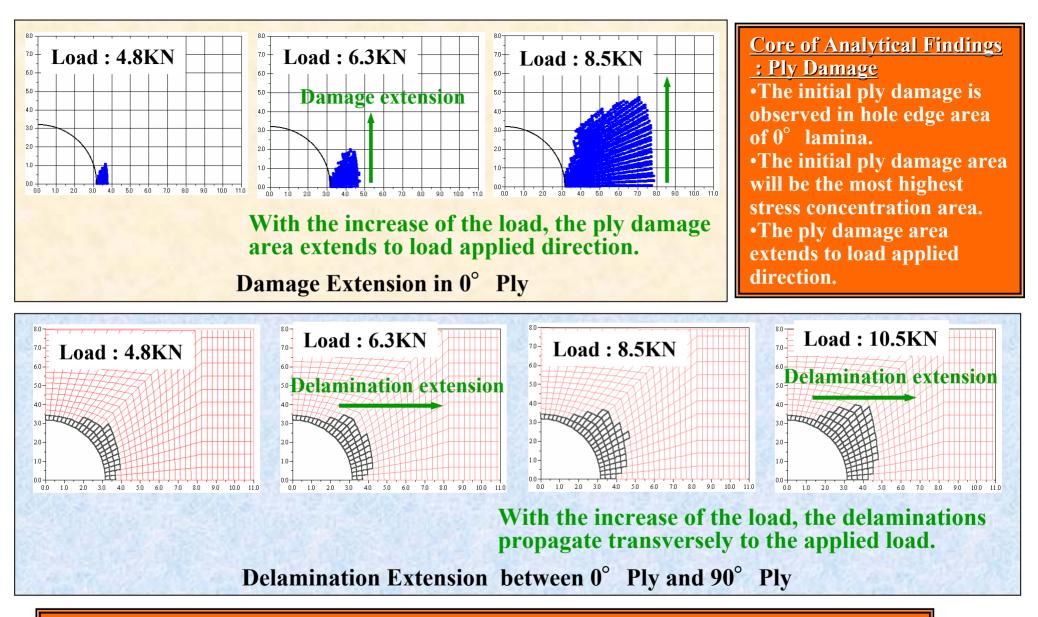
Analytical Results

•The delaminations propagate transversely to the applied load.

•All delamination extension behaviors have the features of mode II fracture in present results.
