ENHANCEMENT OF TOW VISUALISATION IN CARBON COMPOSITES

Luke Djukic^{1,2}, Israel Herzberg², Greg A. Schoeppner³

¹ The University of New South Wales, School of Mechanical and Manufacturing Engineering, Sydney, NSW, 2052, Australia.

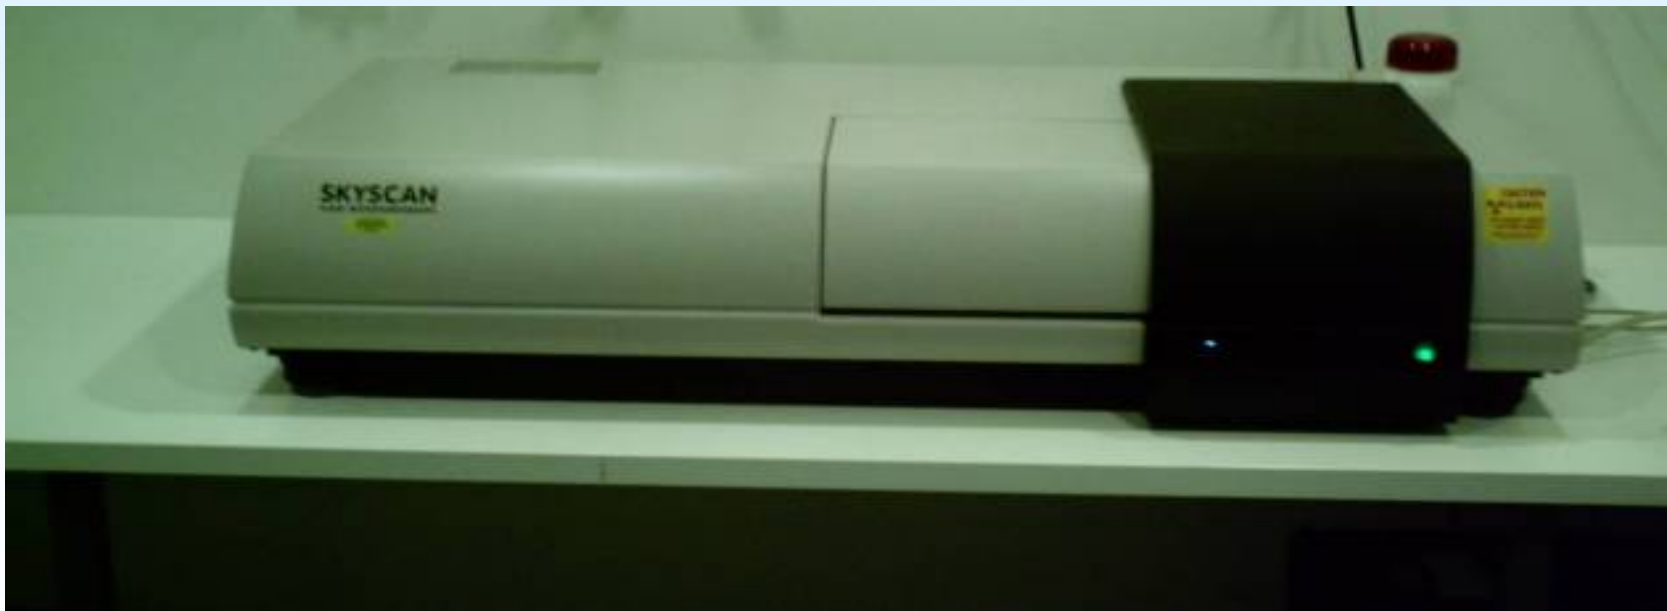
Skyscan 1072

MicroCT Scanning

1) X-ray images acquired at a number of orientations over total angle change of 180° or 360° .

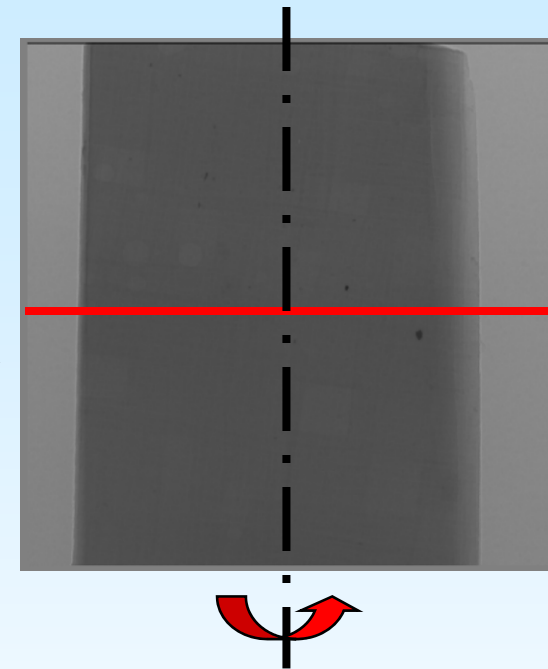
Reported images

2) Line of pixels selected from each image to reconstruct perpendicular cross section.

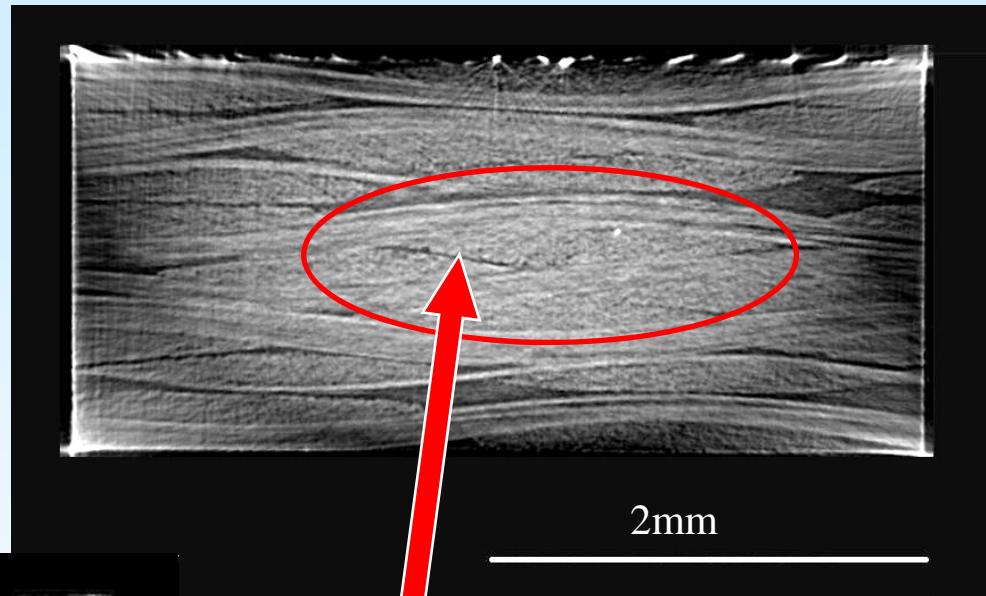
Poorly visualised
tow interfaces

- Tow deformations visible in some locations
- Similar greyscale shades in both resin and tows.

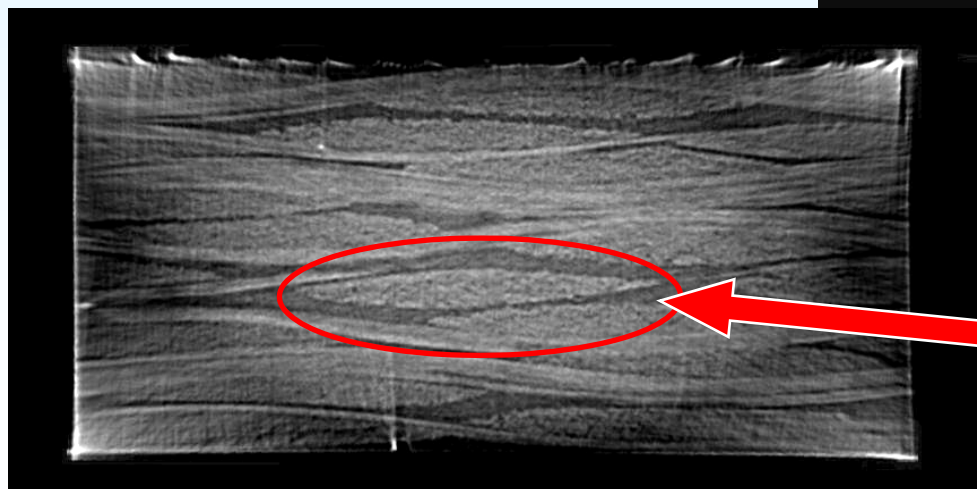
Clearly defined tow with
consolidation deformations,
oriented out of page

- Can discriminate tow direction in some cases
- Tow deformations visible
- Difficulty determining tow interfaces, particularly when tows in contact are aligned in the same direction.
- Leads to need for contrast enhancement.

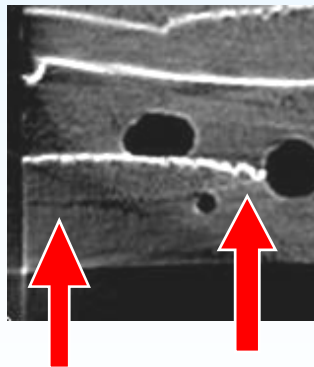
- Appears as a difference in attenuation
- Free edges or corners of samples
- In low density material near material of higher density.

Brightness difference

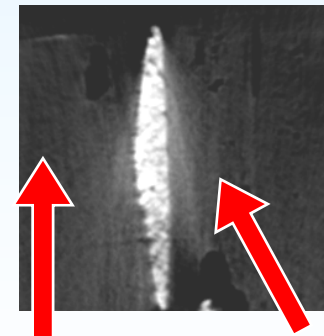
Brightness difference

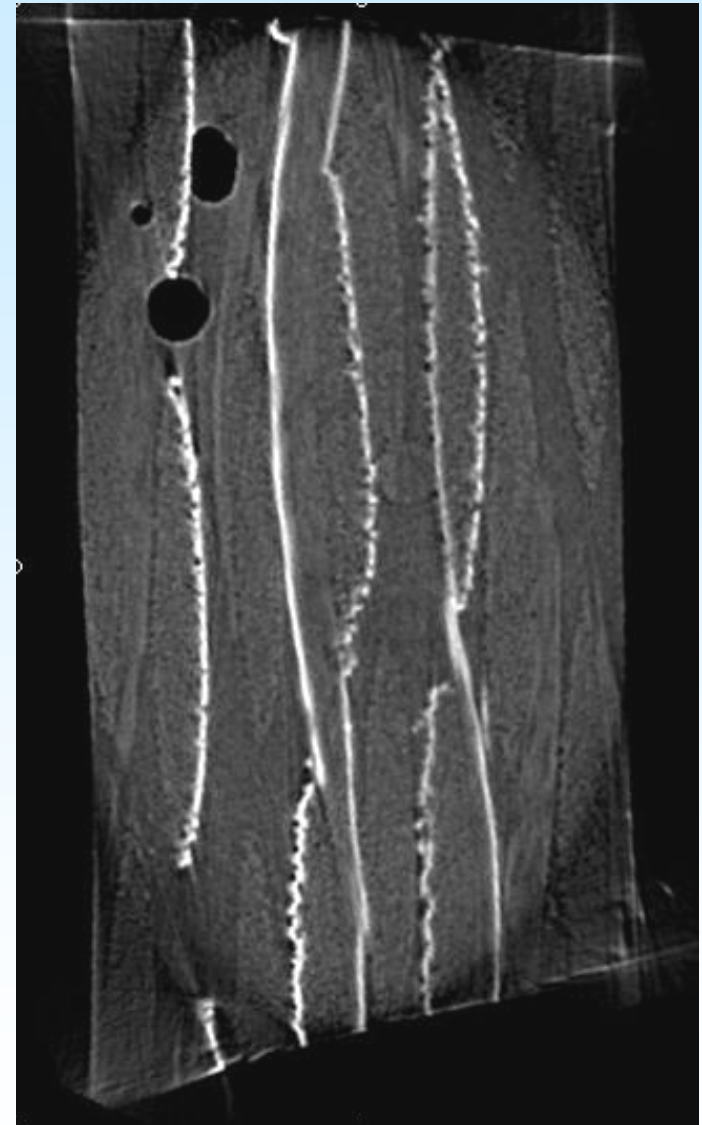
Gold Coating - Fabric

- 25nm and 50nm gold layers applied to dry fabric – sputter coating
- VBRI with polyester resin.

- Allows good visualisation of ply interface.
- Visualised layer thickness is not indicative of actual dimension.
- Not able to see interface of tows within same ply.

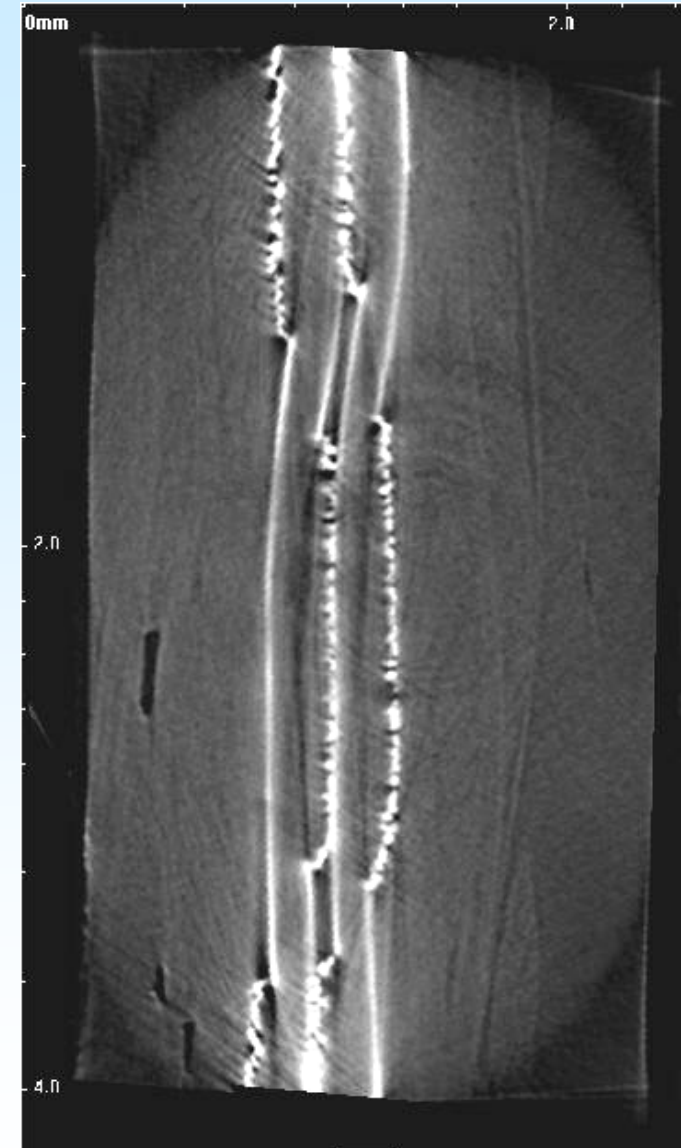
Copper Coating - Fabric

- Carbon fabric coated with copper using vapour deposition technique prior to infusion
- VBRI.

- Similar results to gold
- Additional beam hardening artifact around copper layers.

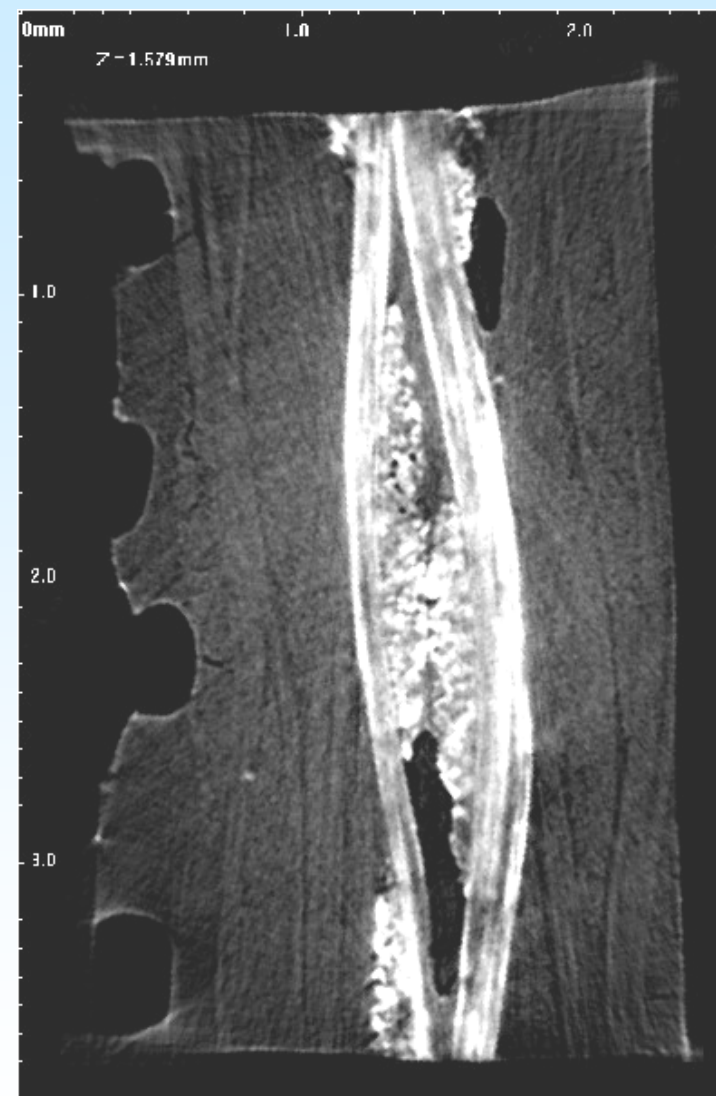
Iodine Tracer Coating – Fabric

- Plies soaked in Iodine based medical tracer (Isovue 370).
- Two coated plies at centre of lay-up.
- VBRI.

- Fabric found to stiffen as a result of soaking
- Poor distinction of tow interfaces within ply
- Coated fabrics contrast well to uncoated
- Higher void content than gold specimen.

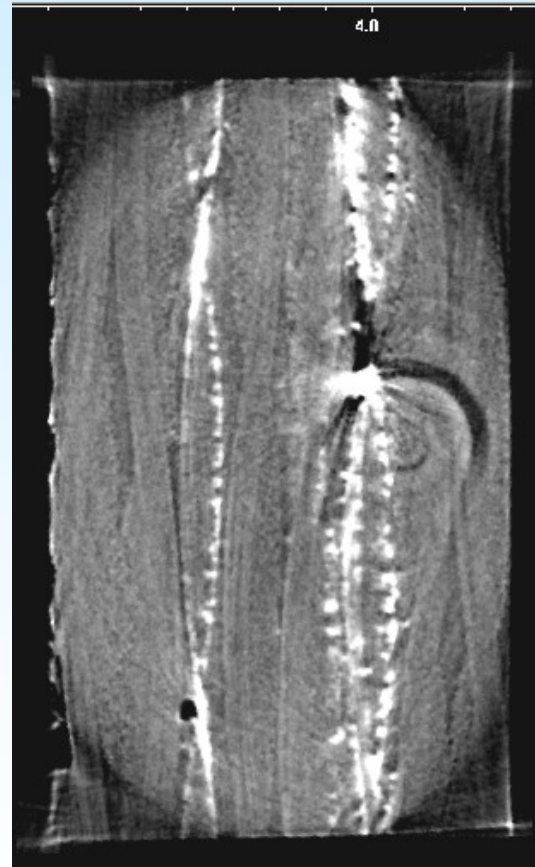
- Barium Sulphate or Gadolinium Fluoride particles in propanol solution
- Wet lay-up with vacuum compaction.

- Particles found by scan, but poor contrast generated due to poor dispersion
- High level of artifact due to concentrated high density regions.

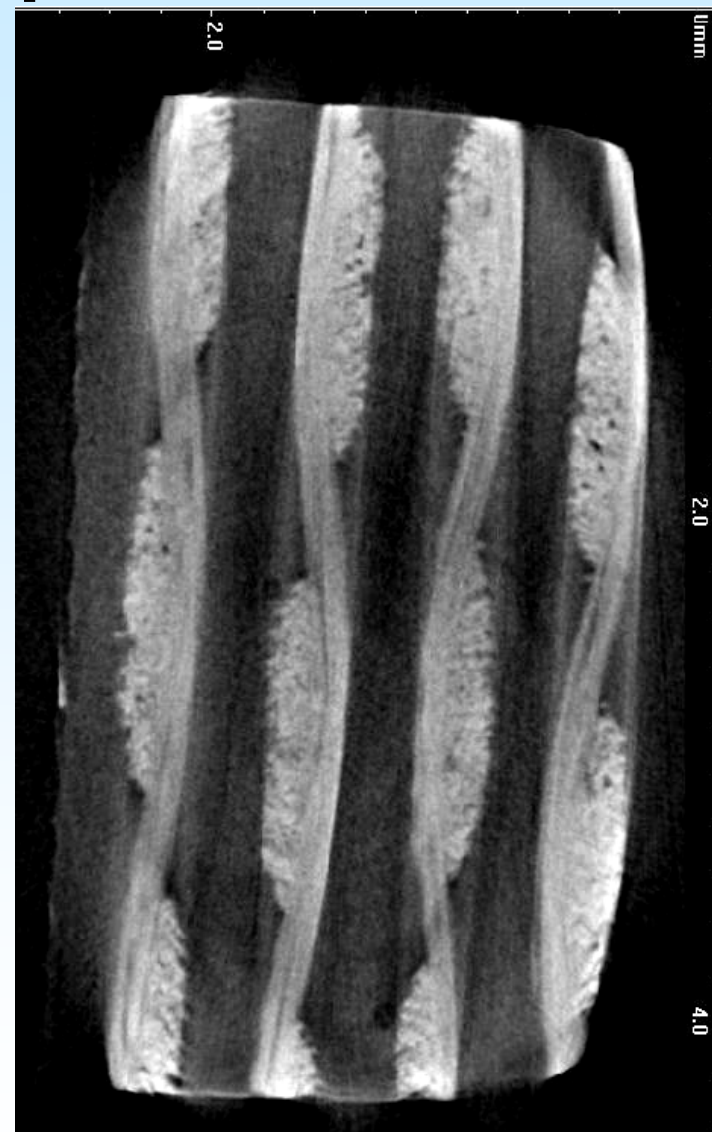
Glass Fabric Comparison

- Interleaved glass and carbon fabrics
- Wet lay-up with vacuum bag compaction.

- Visualisation of glass much less problematic than carbon
- Some beam hardening artifact - light and dark patches within carbon
- Poor distinction of tow interface within glass ply, but better than carbon.

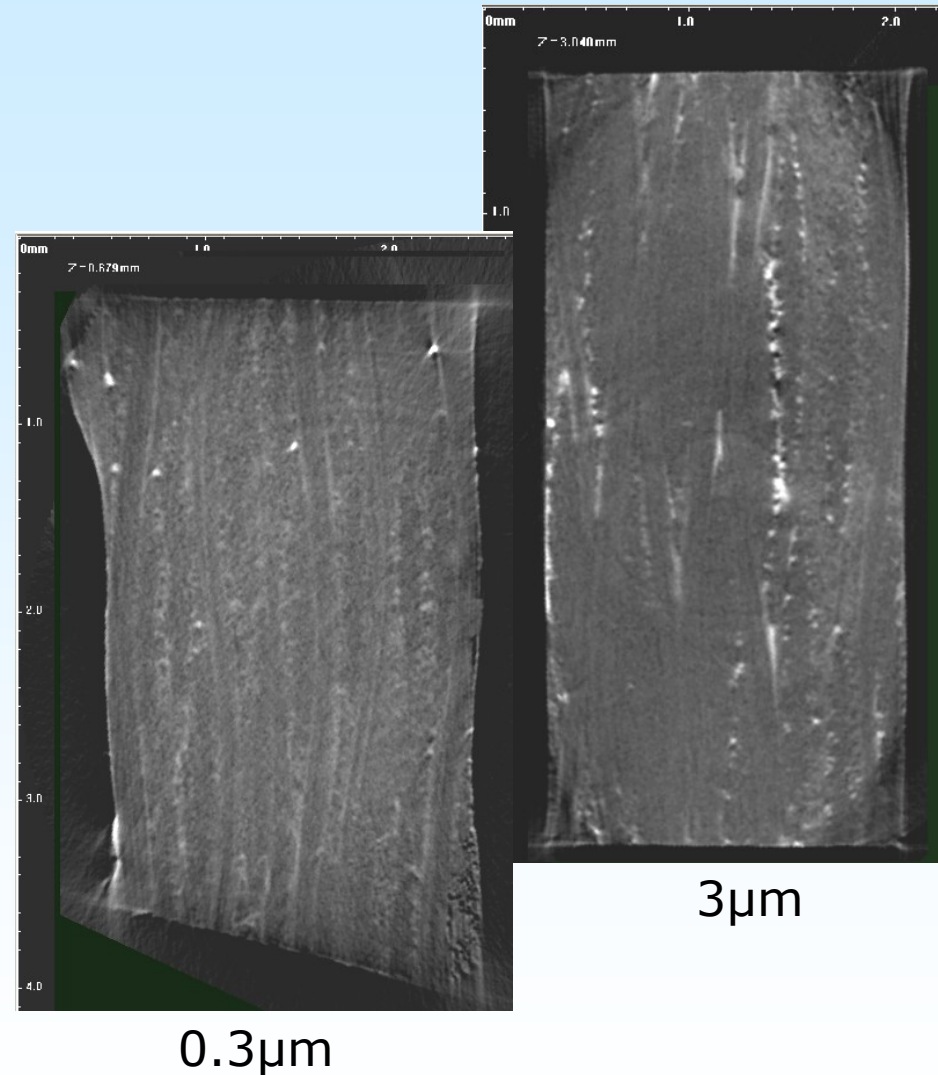
Aluminium Oxide – Resin Additive

- Aluminium oxide polishing powder resin additive
- 3 μ m and 0.3 μ m grit sizes
- VBRI.

- 3 μ m: settling on tow interfaces in uncontrolled fashion
- 0.3 μ m: more uniform dispersion than 3 μ m
- Presence of 0.3 μ m powder in tows reduces contrast
- Need controlled settling on tow interfaces.

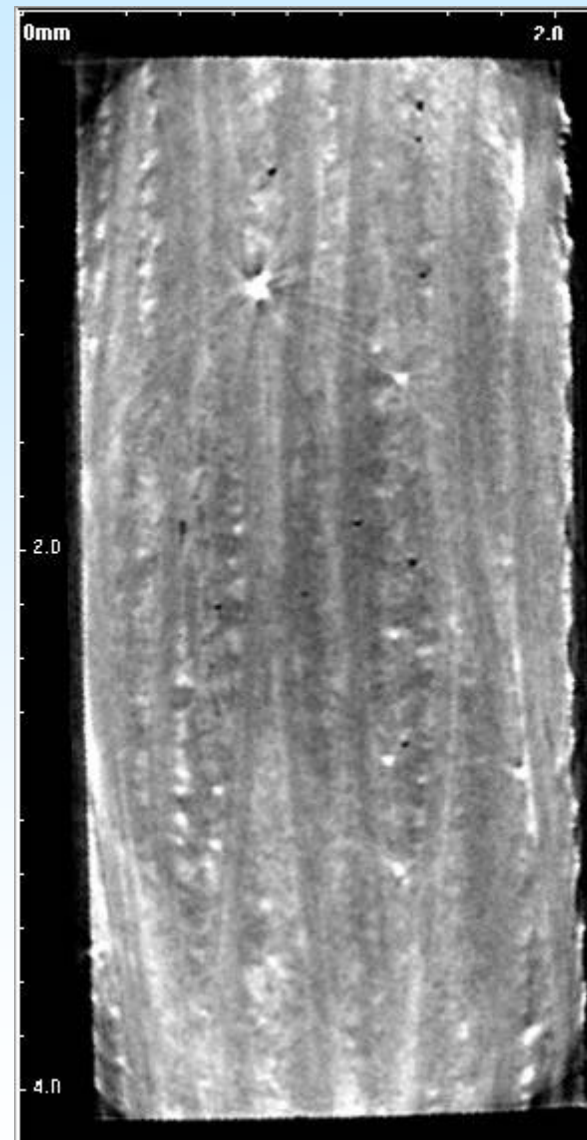
Barium Sulphate – Resin Additive

- Barium Sulphate
- 1:10 mass ratio between resin and particles
- Wet lay-up with vacuum compaction.

- Better dispersion than bone cement due to wet lay-up
- Entire resin highlighted
- Tows also highlighted, but to lesser extent.

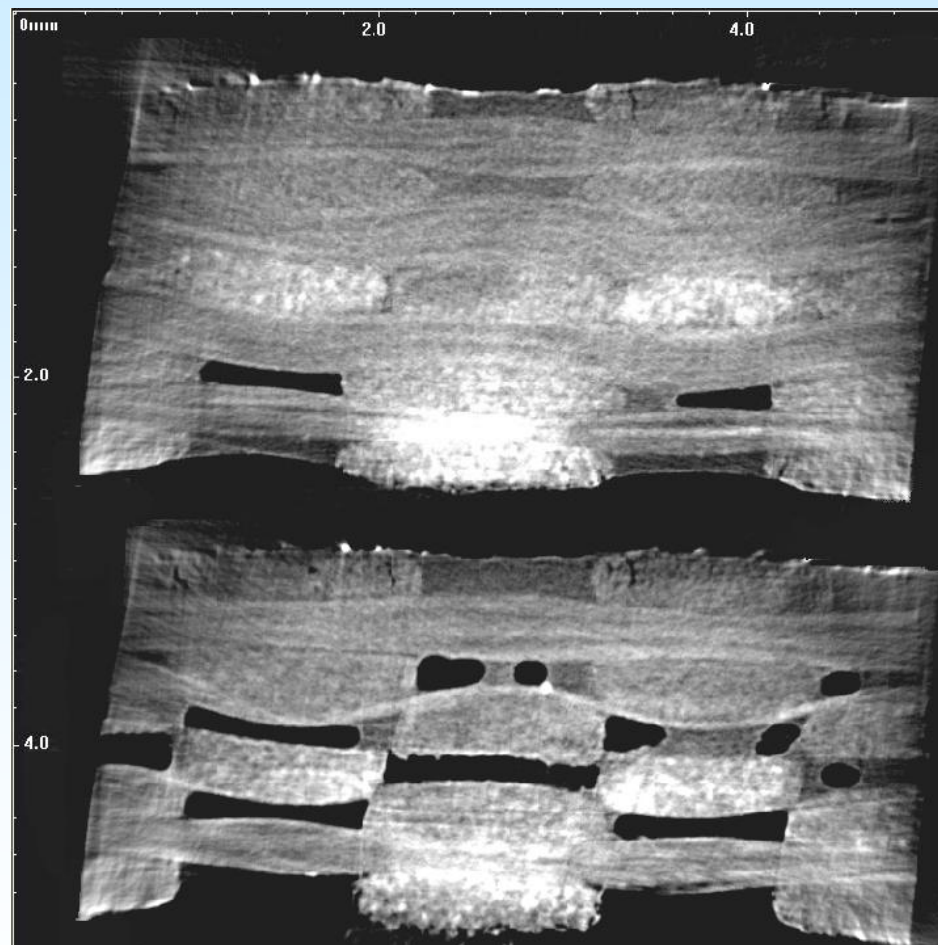
Iodine coated 3D preform

- Coated in Iodine based medical tracer under pressure prior to infusion
- Necessary due to observed stiffening of fabric during coating
- VBRI.

- Some non-uniformity in coating
- Difficult to determine exact tow interfaces
- Need multiple levels of contrast.

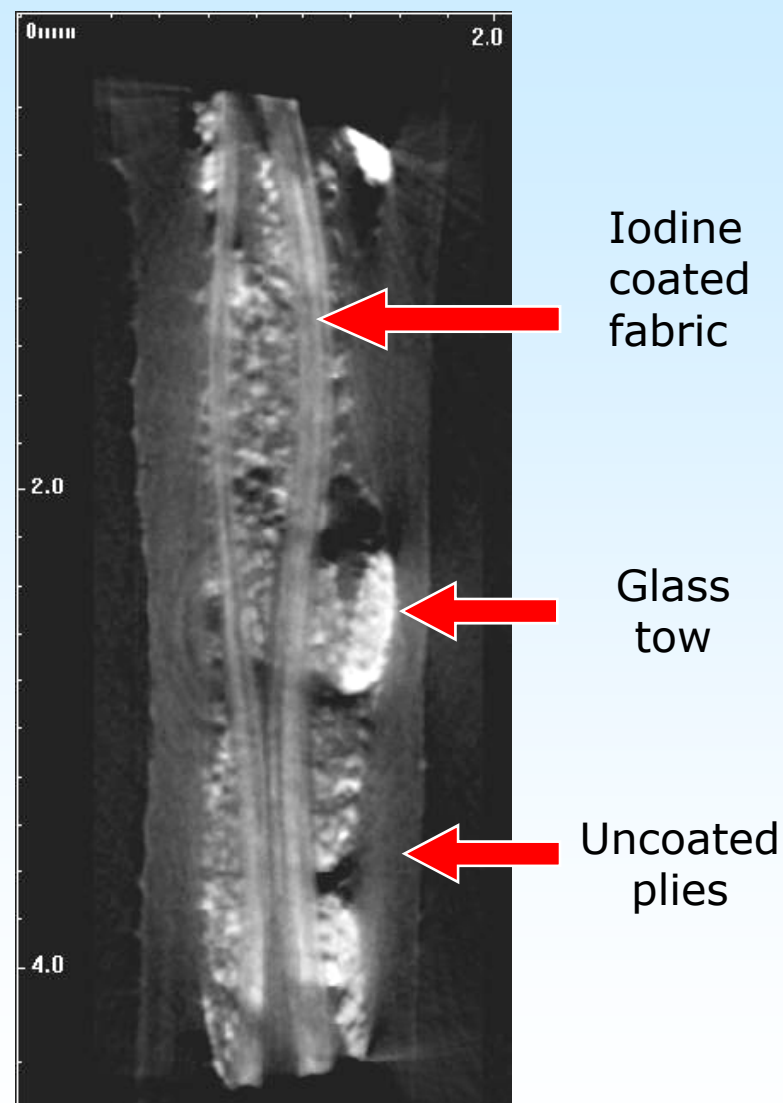
Iodine Fabric with Glass Stitching

- Two layers of plain weave coated with Iodine tracer
- Woven together with glass tows
- Two untreated layers of carbon plain weave placed in either side
- Wet lay-up with vacuum bag compaction.

- Difficulties due to beam hardening artefact and regions of coated fabric appearing as similar
- Densities separable by greyscale level for most part.

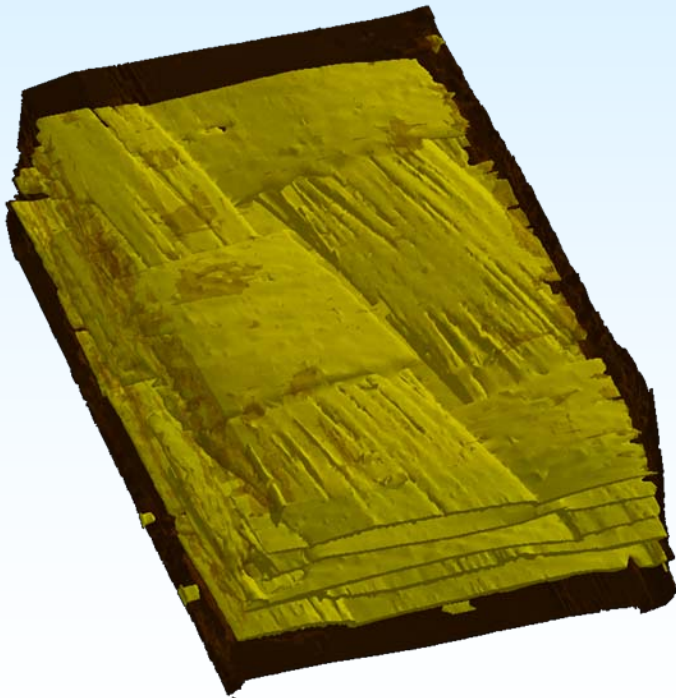
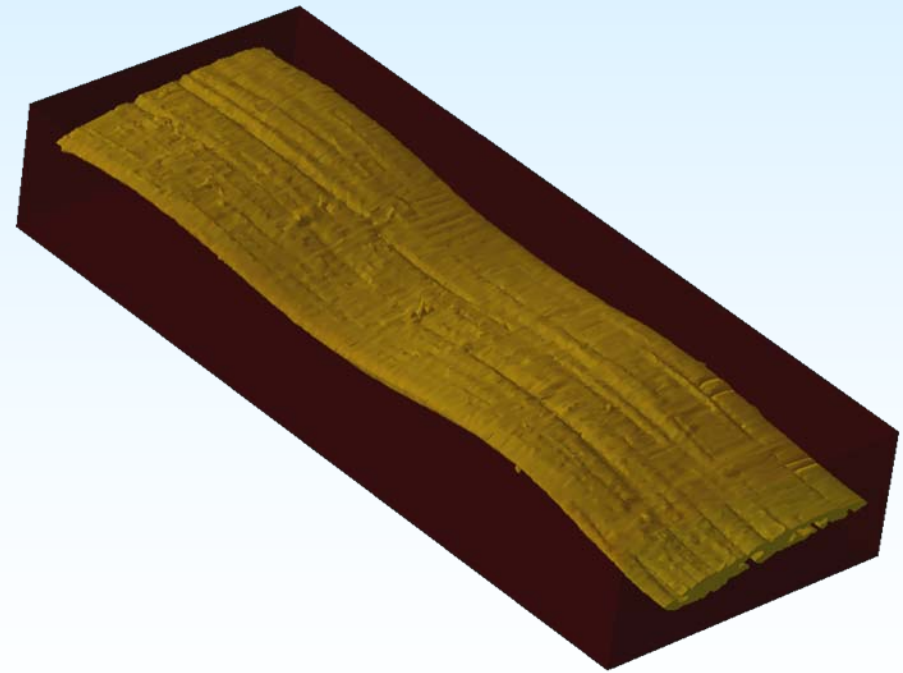
Gold 3D Reconstructions

- Reconstructions made from cross-sectional images in 3D Creator
- Plain weave:
 - Reconstruction of gold layers on fabrics
 - Grooves in tow surface indicate fibre direction.
- Individual tow:
 - Outline of tow – interior not reconstructed.

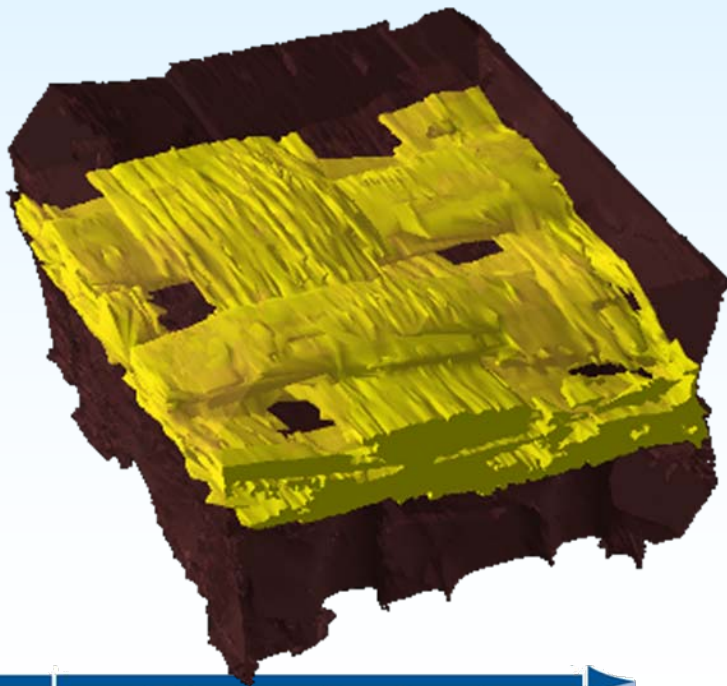
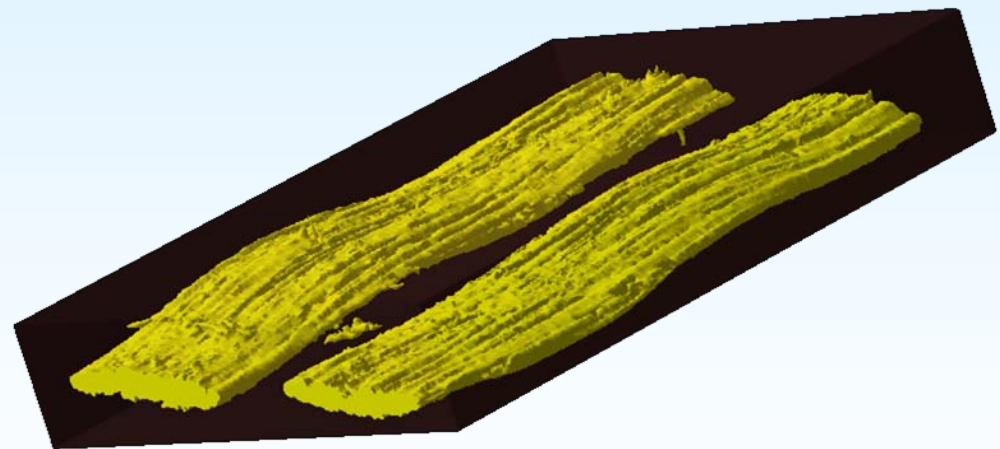
Iodine 3D Reconstructions

- Plain weave:
 - Reconstruction of entire fabric.
- Individual tows:
 - Have to account for beam hardening artifact, resulting in loss of tow perimeter definition
 - Inside of tows reconstructed
 - Artifacts reconstructed along with tows.

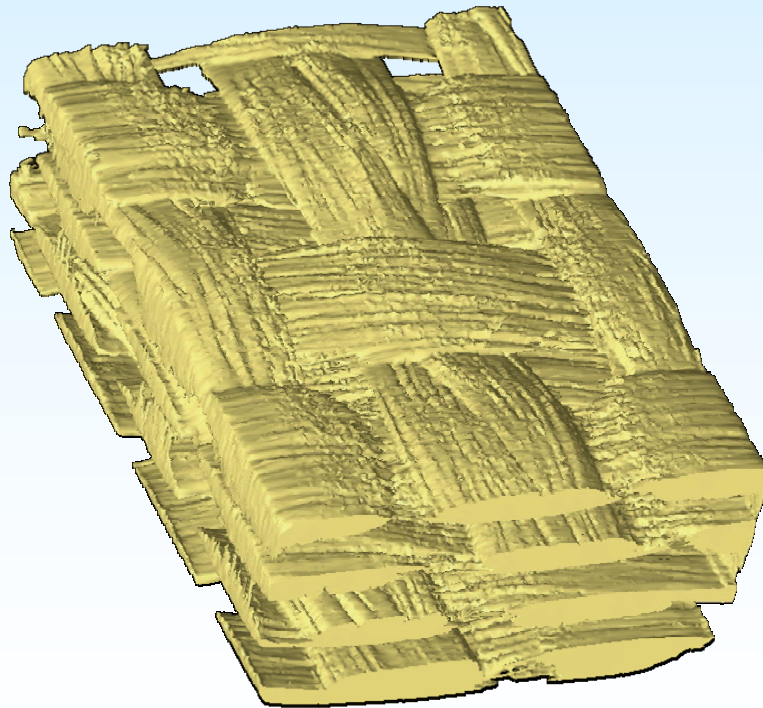
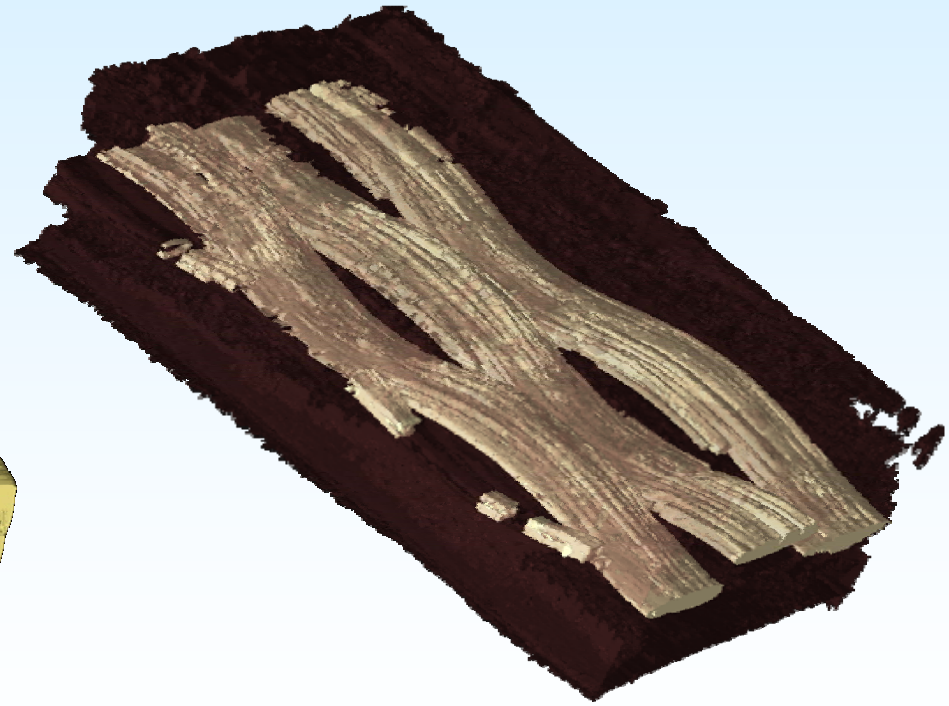
Glass 3D Reconstructions

- Plain weave:
 - Loss of accuracy at some locations
 - Adequate reconstructions without additives.
- Individual tows:
 - Loss of accuracy leading to "broken" edges.

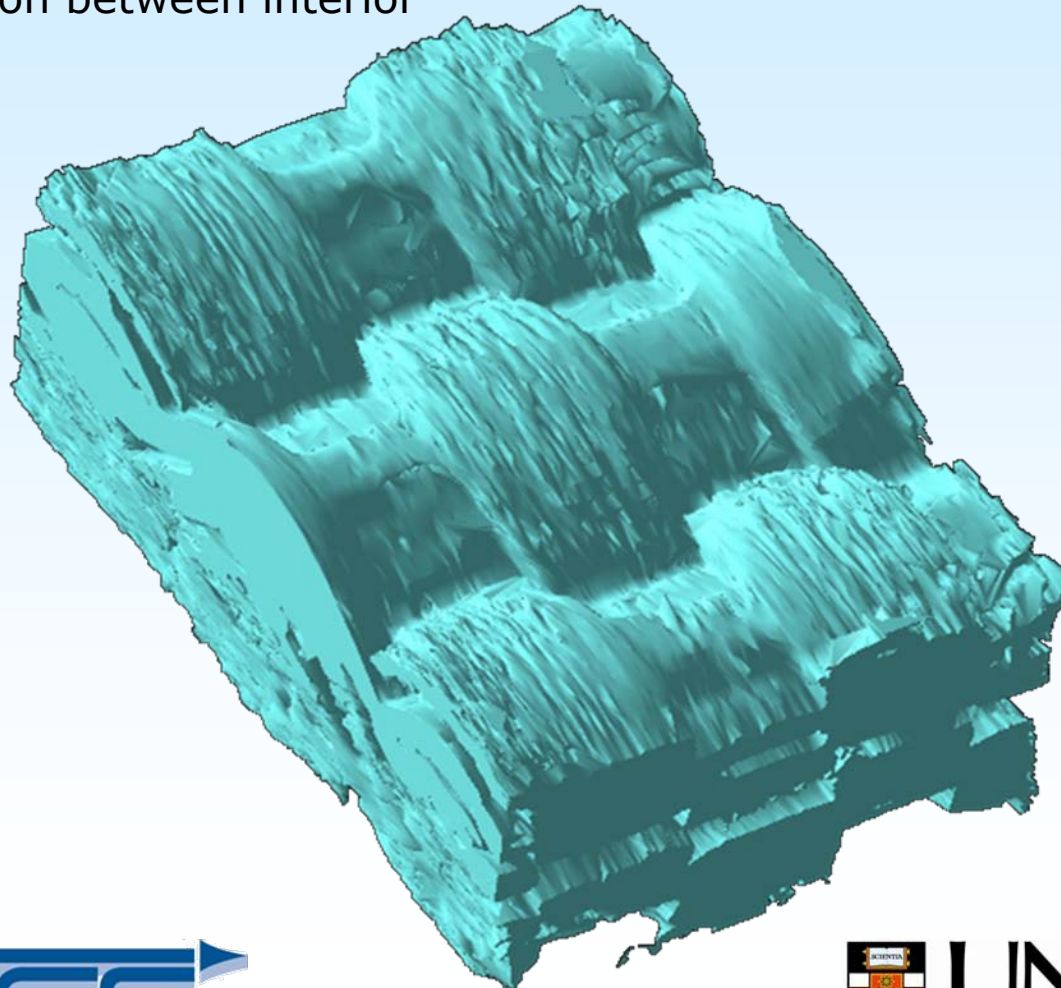
Iodine coated 3D carbon preform

- Good representation of exterior
- Poor distinction between interior tows.

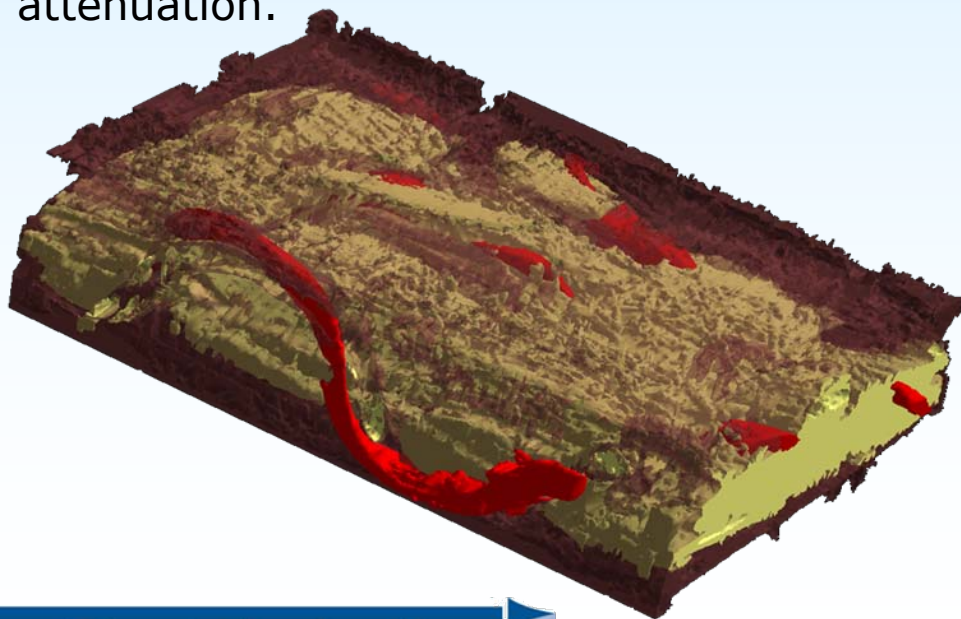
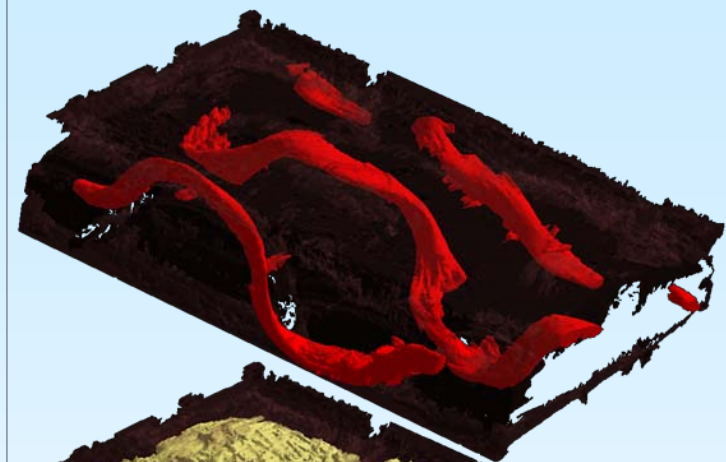
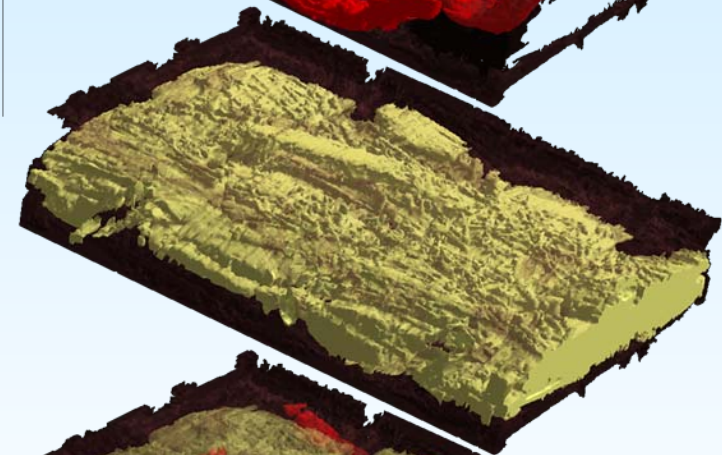
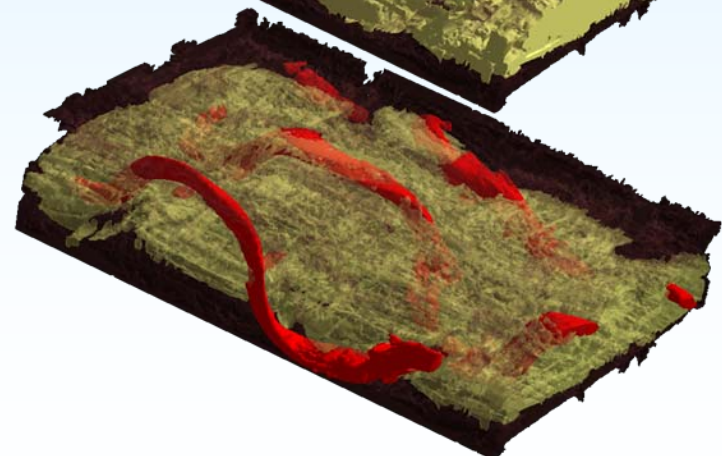
Iodine Fabric with Glass Stitching

- Iodine coated plain weaves in centre (beige), layer reconstructed poorly
- Through thickness stitching with glass tows (red)
- Untreated carbon plain weave outer plies (brown)
- Separate into different volumes using X-ray attenuation.
