Behaviour of Ceramic Coatings on Polymer Composites against Laser Exposure

George Holiday^{1,2} - EngD (Sep 2023 – Sep 2027)

National Composites Centre¹, University of Bristol²,
University of Oxford³

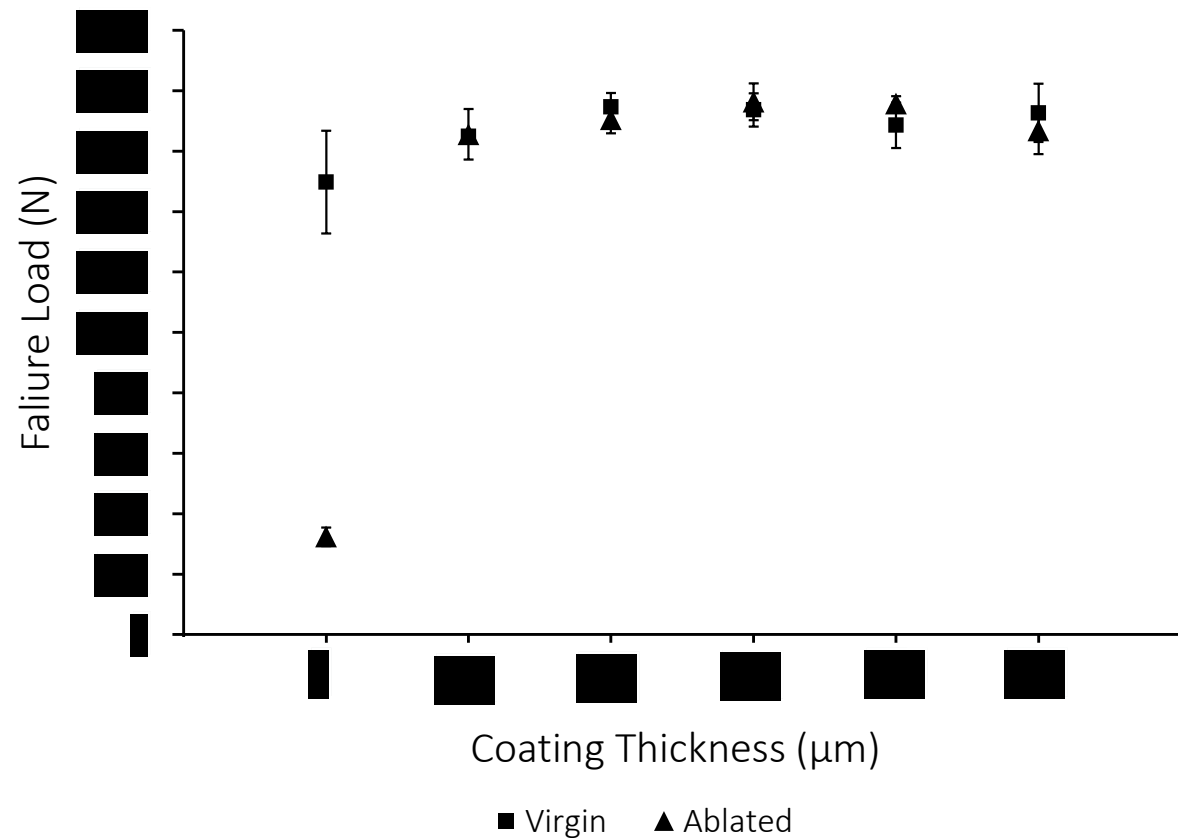
4 Point Bending Results

- 80% drop in strength for uncoated
- No drop for any coating
 - ⇒ Coating is **insulative** and prevents substrate **strength degradation**

1. Ceramic coatings are highly effective at shielding CFRP against these laser conditions
2. Variability in coating properties determines reliability
