April 13th, 2018

CRITICAL INFRASTRUCTURE IN BENGAWAN SOLO RIVER

RIA ASIH ARYANI SOEMITRO

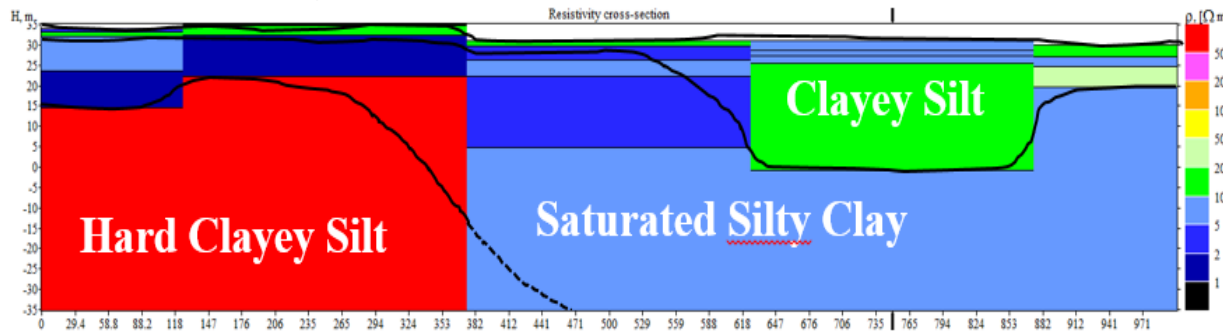
Soil resistivity at downstream area

- Downstream area is dominated by silty and sandy soil, whilst estuary area is dominated by clayey soil.
- It is due to coarse grain firstly deposits in the down-stream area.
- The soil specific gravity and soil plasticity value proves the soil composition at down stream and estuary area.

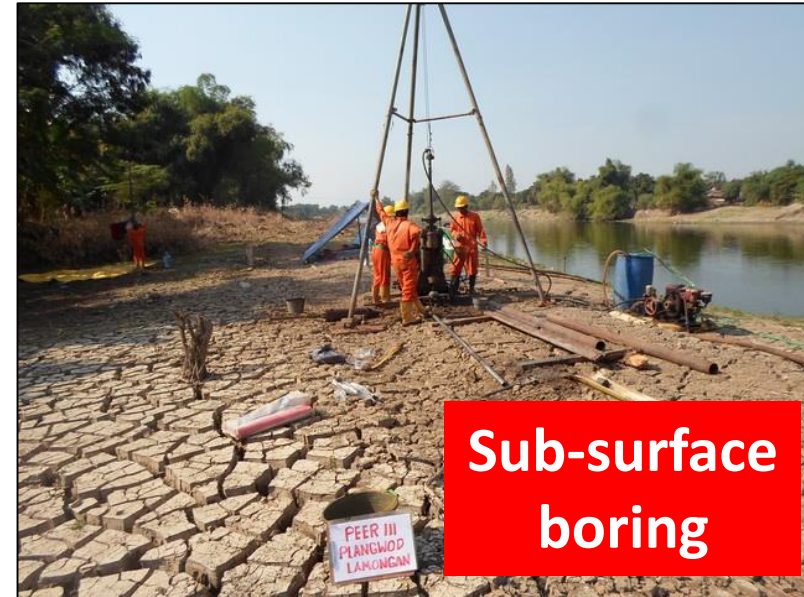
- River embankment soil condition (sub-surface)
 - Clayey soil stratified at upper sub-surface layer
 - Silty clay soil stratified at bottom sub-surface layer

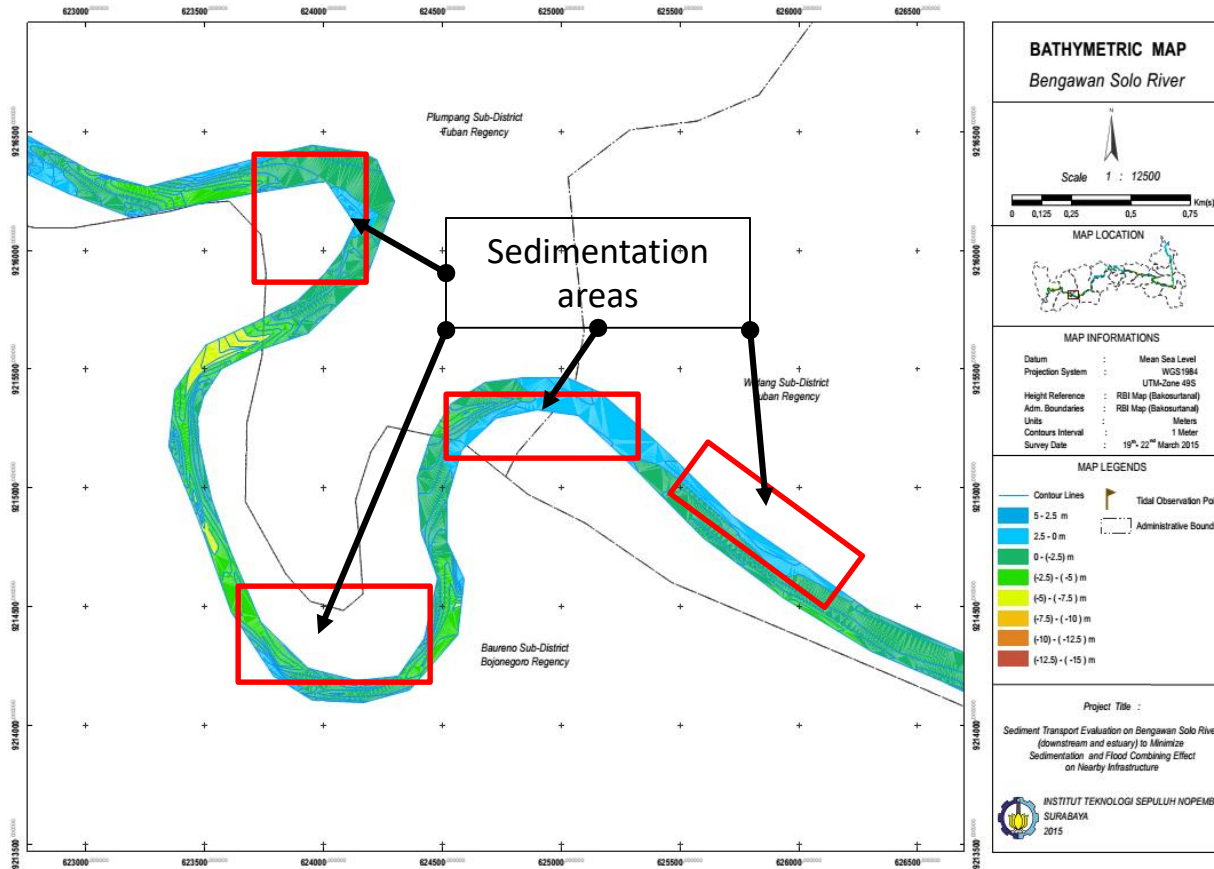
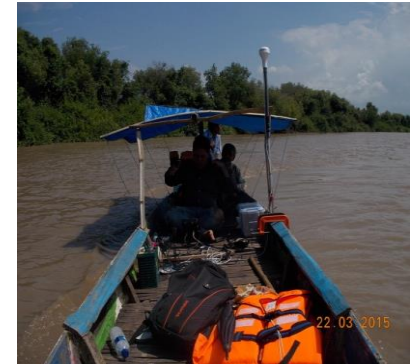
Figure. River bathymetry result

The riverbed levels are varied along river stream indicating the sediment transport occurred frequently.

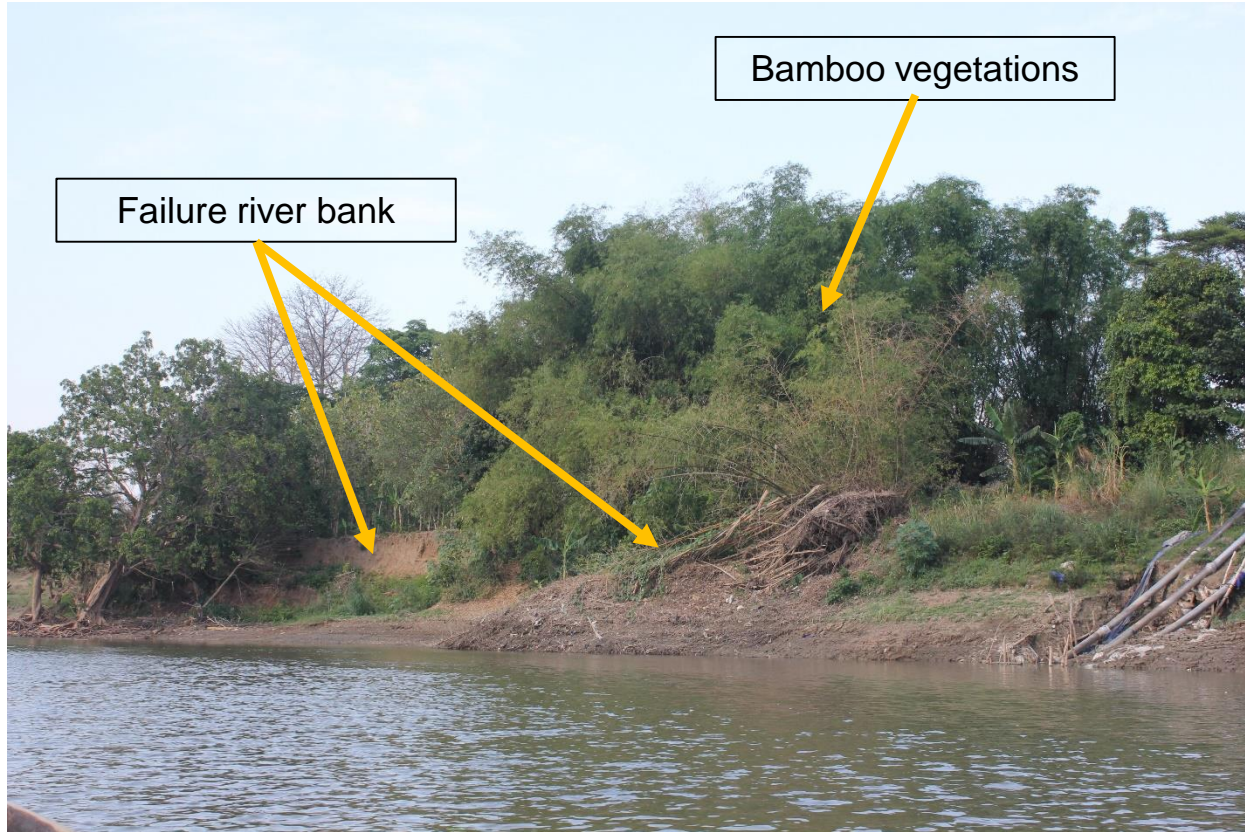
River bank vegetation and slope failure in Bengawan Solo River

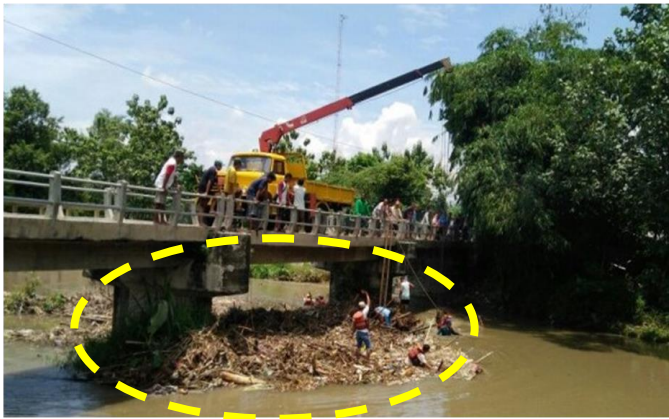
- Massive dumped bamboo in the bridge pier, 2016 (Source: Timlo.net)

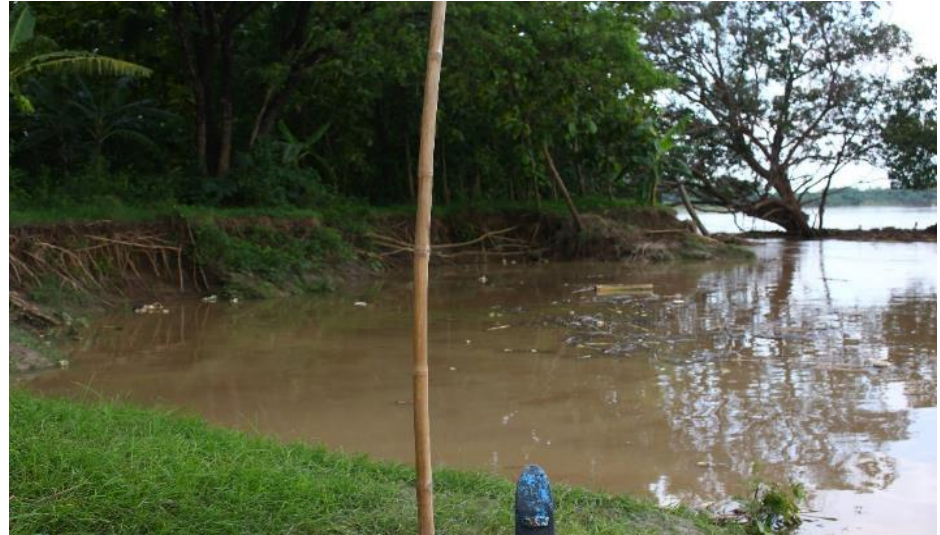
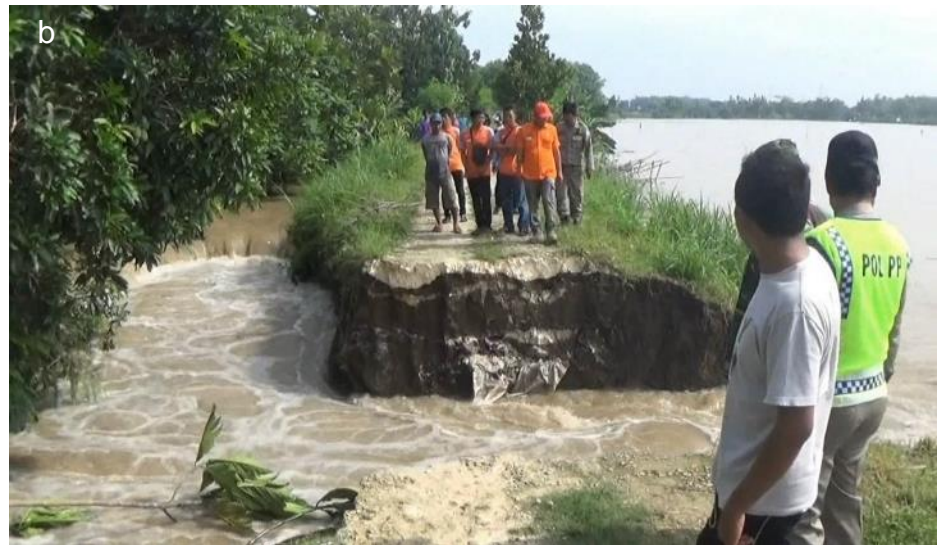
- It stated in the Indonesian National Code (SNI) that river with 2000 – 5000 m³/s of periodic flood should have 1.20 m in minimum of free board otherwise the overtopping flow gives an extra force to the embankment structure.

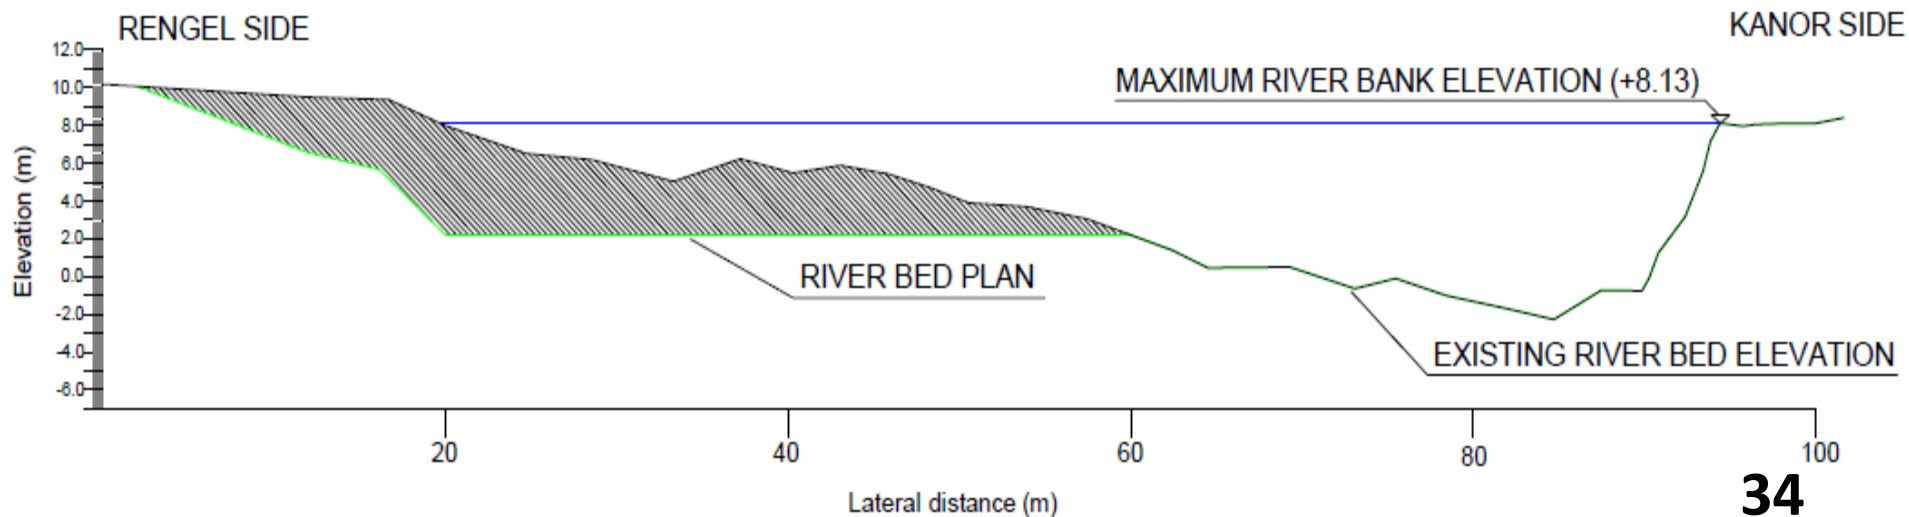
RIVER PROFILE AT KANOR SECTION, BOJONEGORO

- River bed erosion occurred at Kanor side due to high flow velocity.
- Sediment deposition exist around inner bend at Rengel side developed by low flow velocity.
- Excessive flood is frequently happened in this section.

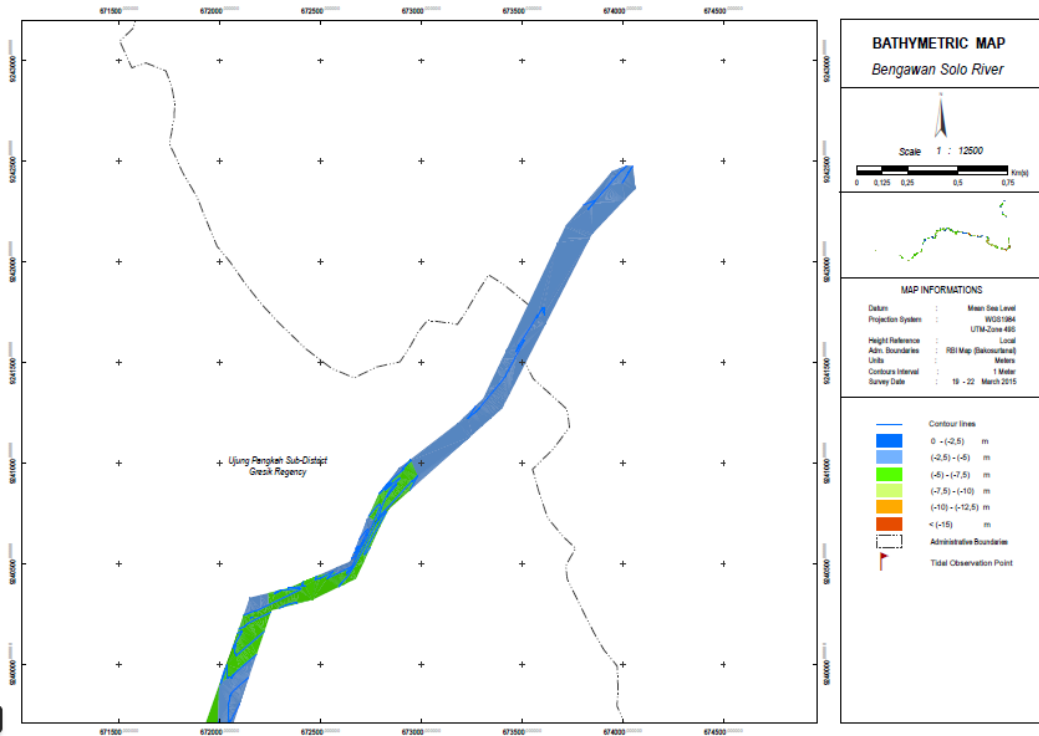
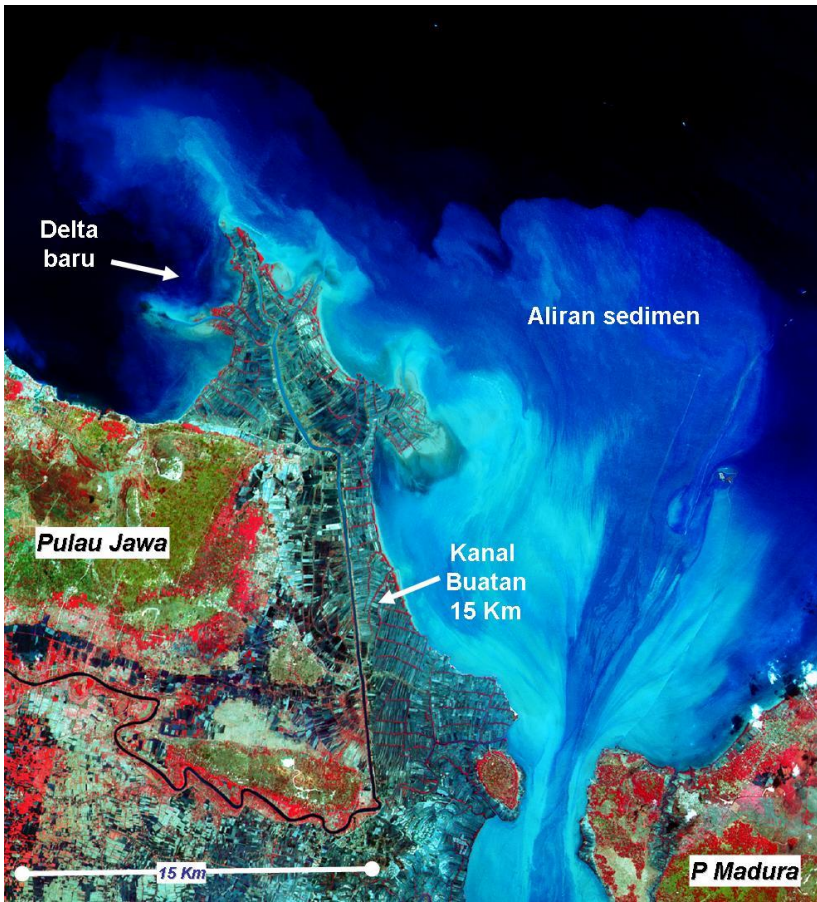
EVALUATION - DEPOSITION DEPTH CHANGING AT ESTUARY

- Bed elevation is increasing near the shore at estuary area
- Sediment deposition was ended in the shore as the final of river path

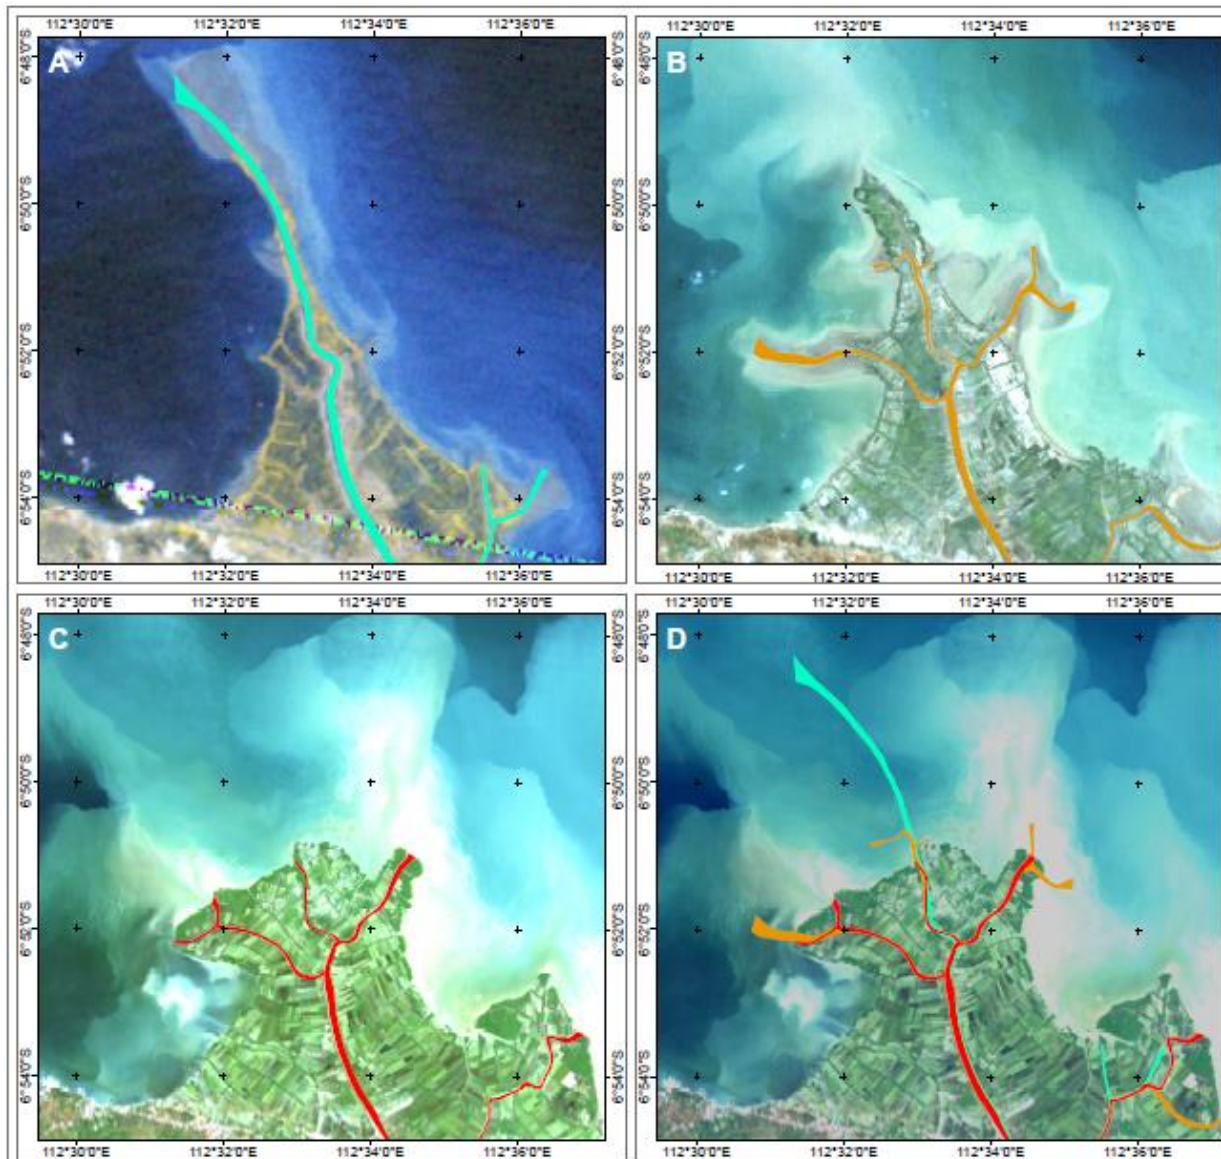
SEDIMENT EFFECTS ON THE ESTUARY

- Sediment quantities investigation in Bengawan Solo River-Bojonegoro:
 - Dry season: 50 mg/L
 - Rainy season: 1700 mg/L
- Sediment rate: 841.866 m³/year (1st year result).
- Average longitudinal growth in estuary around 70 m per year (Hoekstra et al, 1989).

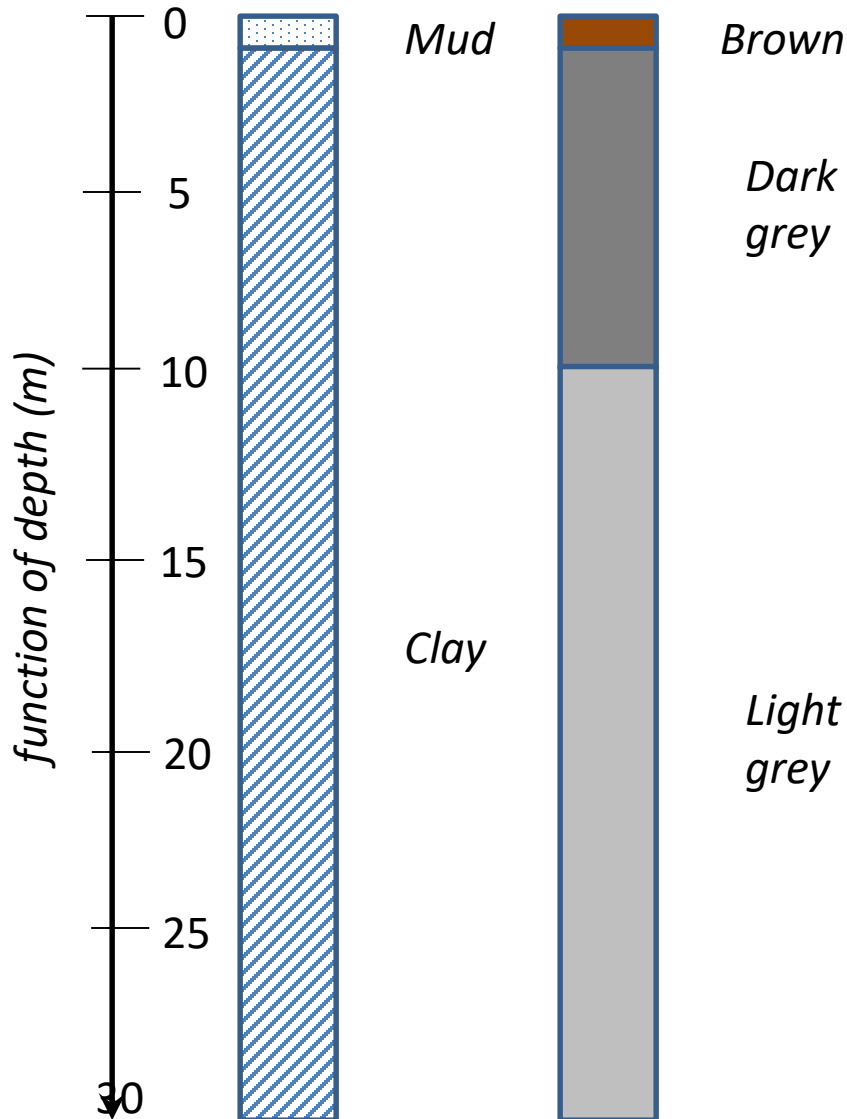
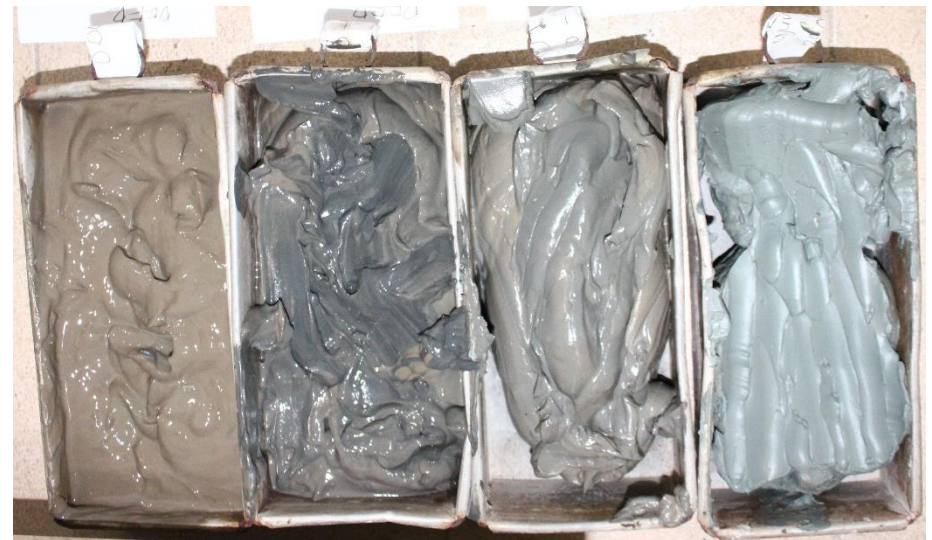
EVALUATION - SOIL BORE LOG AT SHORE IN ESTUARY

- All of the soil below shore is very soft soil with having $N_{SPT} 0$
- Sediment material at shore is dominated by fine grain material
- The soil colour describes the age of sedimentation process

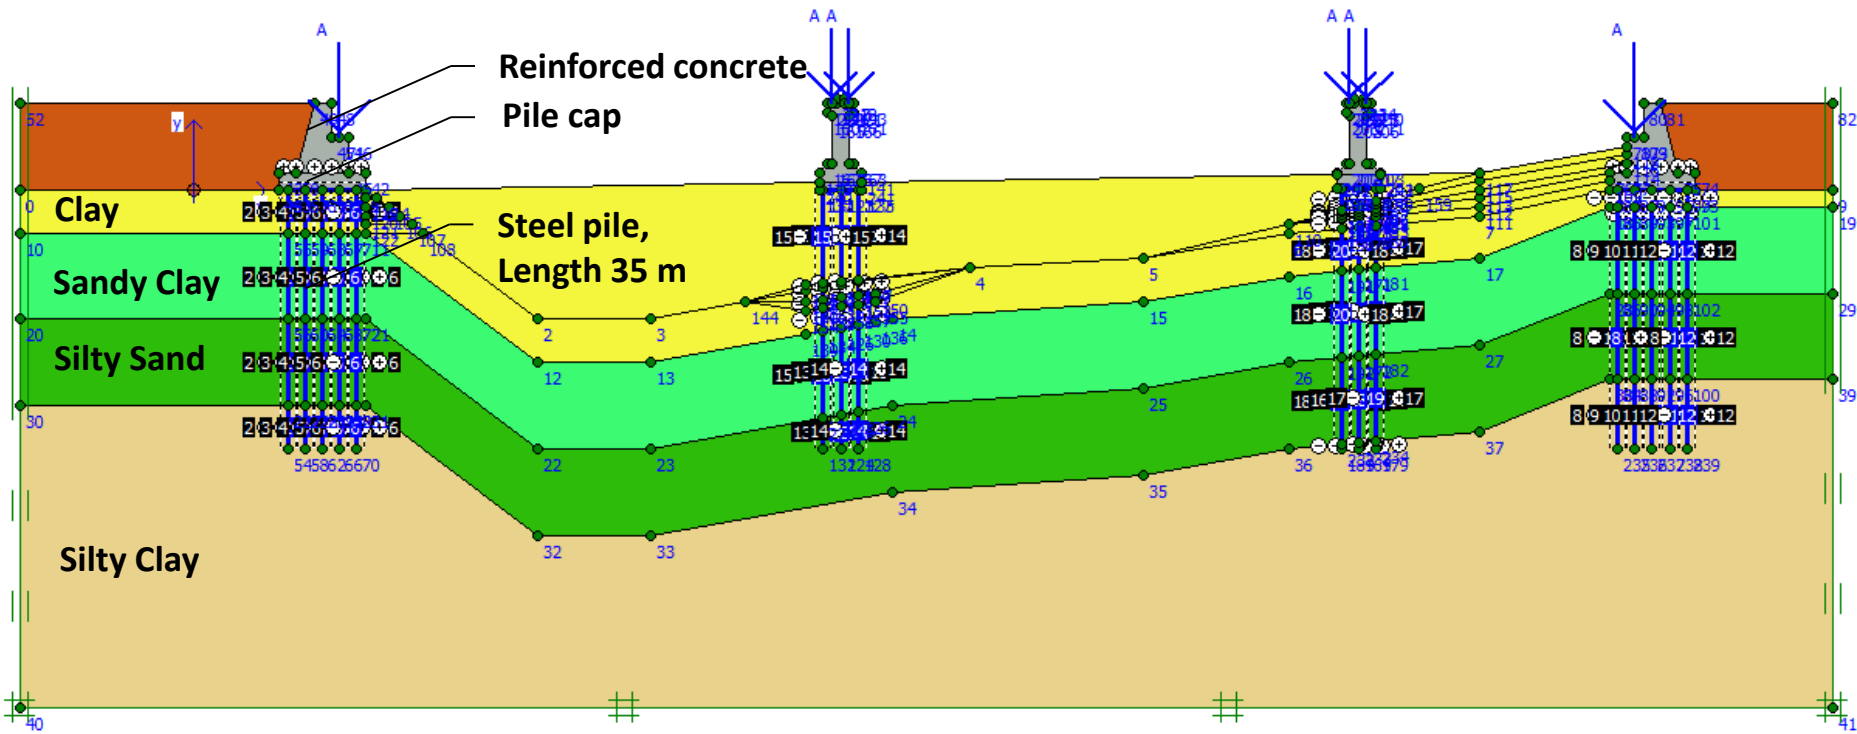
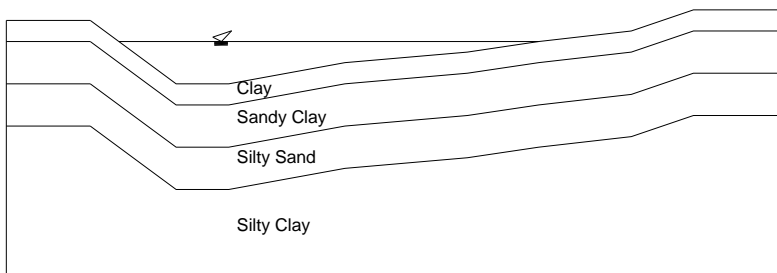
KARANG BINANGUN

- Load of sediment and water flow increases due to water level
- Foundation stability was influenced by additional load from sediment and water
- Karang Binangun, Karang Geneng and Laren bridges are vulnerable to water level fluctuation below 5 m
- Sembayat was the most stable structure since no impact area existed on the foundation

- Karang Binangun was the most critical condition due to water level change
- The slope is tend to be collapsed due to water level change

Location	Initial	Remark	Scoured 1 m	Remark	Scoured 2 m	Remark	Scoured 3 m	Remark
Karang Binangun	1.119	< 1.5	1.118	< 1.5	1.115	< 1.5	1.111	< 1.5
Karang Geneng	1.808	> 1.5	1.791	> 1.5	1.741	> 1.5	1.730	> 1.5
Laren	1.781	> 1.5	1.783	> 1.5	1.779	> 1.5	1.779	> 1.5
Sembayat	1.644	> 1.5	1.618	> 1.5	1.615	> 1.5	1.611	> 1.5

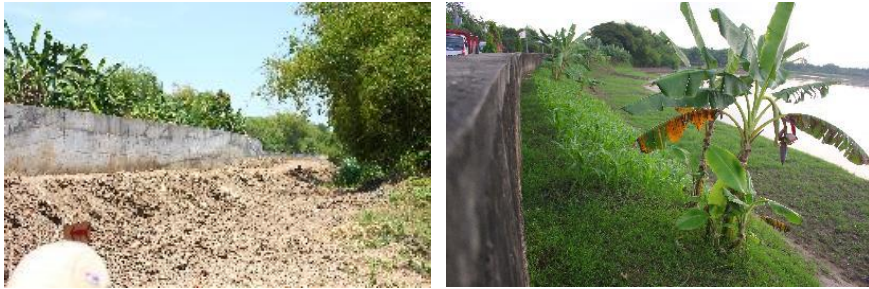
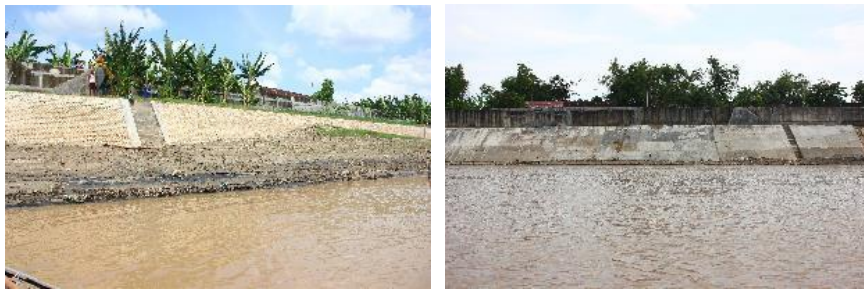
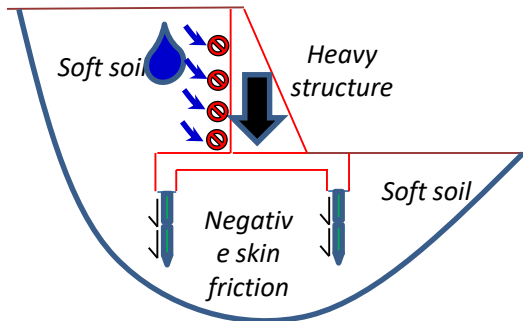
Retaining wall

- **Heavy** structure since constructed by reinforced-concrete and rock material
- Pile bearing capacity is equal to **1/3 of self-weight** of the wall structure
- Piles are laid on the soft soil which has **low strength** and **high compressibility**
- Water is **difficult** to find the way out (soil piping is possible)
- Fill behind the wall affects soil settlement which inducing **negative skin friction** to the piles
- Soil settlement is continued until the **end of consolidation** process

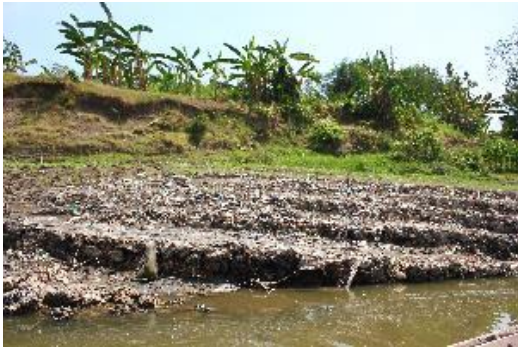
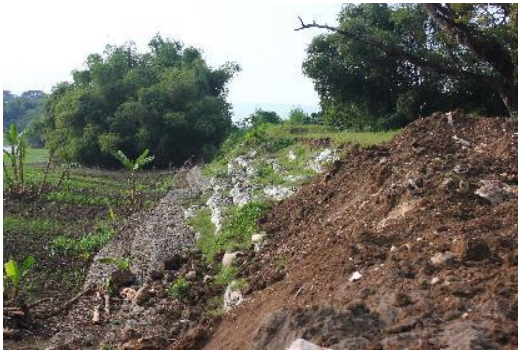
Gabion and sand-bags for slope protection

- Water is flowing into the protection **without** barriers
- Protections are laid on the soft soil which has low strength and high compressibility
- Heavy structure since constructed by rock and sand materials
- Soft soil settlement is completed in the following **hundred years**
