Damage Extension and Failure Behavior of CFRP Specimens in Open Hole Compression Tests and Analytical Simulation

Tetsuji Kato +, Takashi Ishikawa +, Yasumasa Hamaguchi +, Naoya Shikata ++, and Goichi Ben ++

+ Advanced Composite Evaluation Technology Center, Japan Aerospace Exploration Agency ++ Production Engineering Department, Nihon University

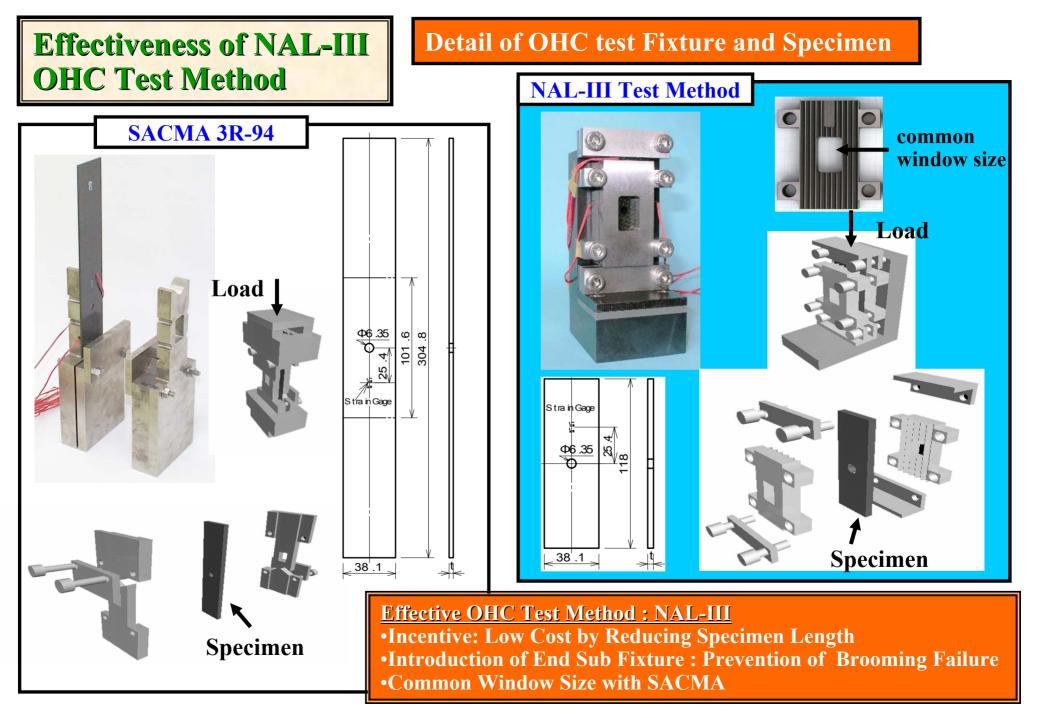
Open Hole Compression Test (OHC) : One of the Most Critical Strengths in Design and Certification of Composite Structures
